Legionella Risk Assessment

15 Woodlands avenue / 11 Aug 2025 / G.A.C. Plumbing and Heating

15 Woodlands avenue

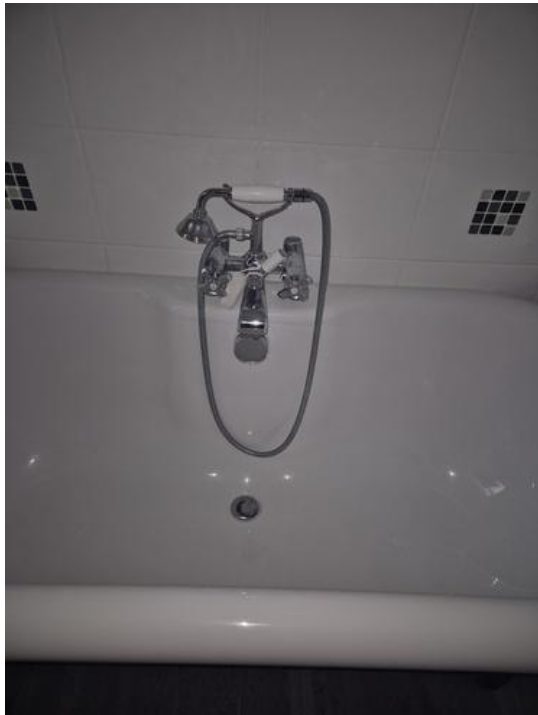
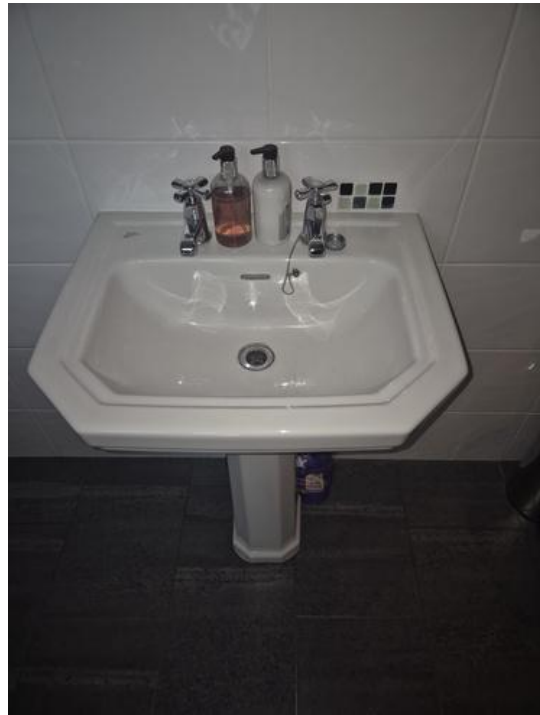
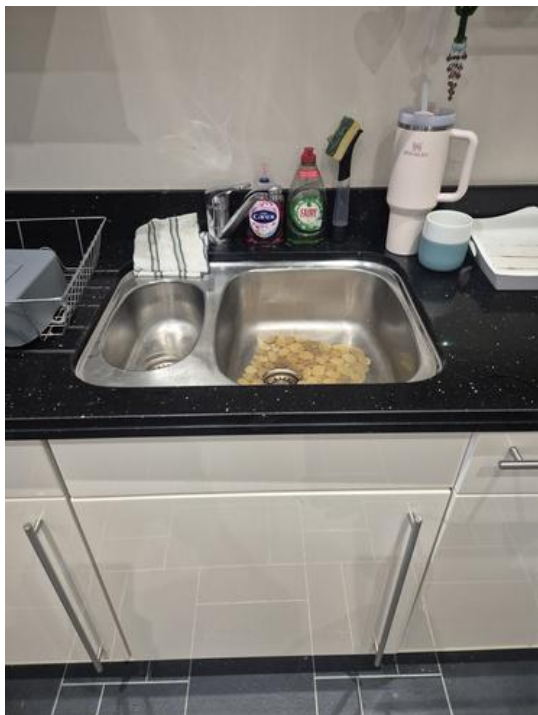
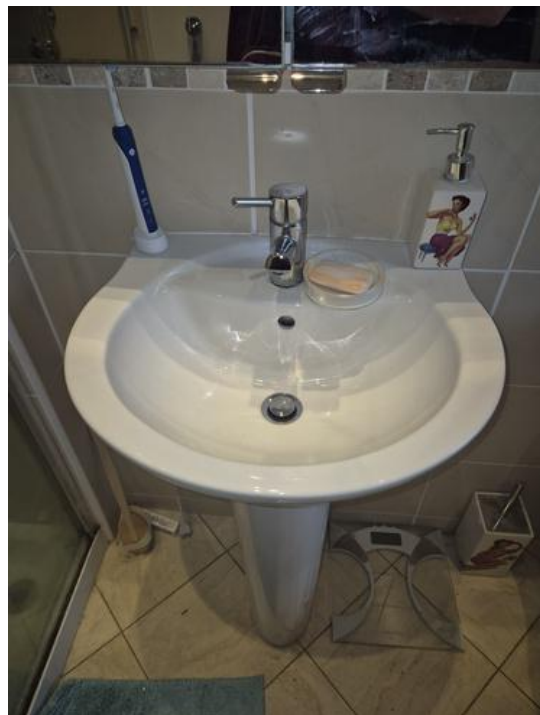
Audit	6 / 6 (100%)
Legionella Risk Assessment	1 / 1 (100%)
Is there any tenant, resident or regular visitor particularly susceptible to legionella due to age, health or lifestyle?	None
Did the person carrying out the assessment have access to competent help and advice when carrying out the assessment?	Yes
Take a photo of the cold water system

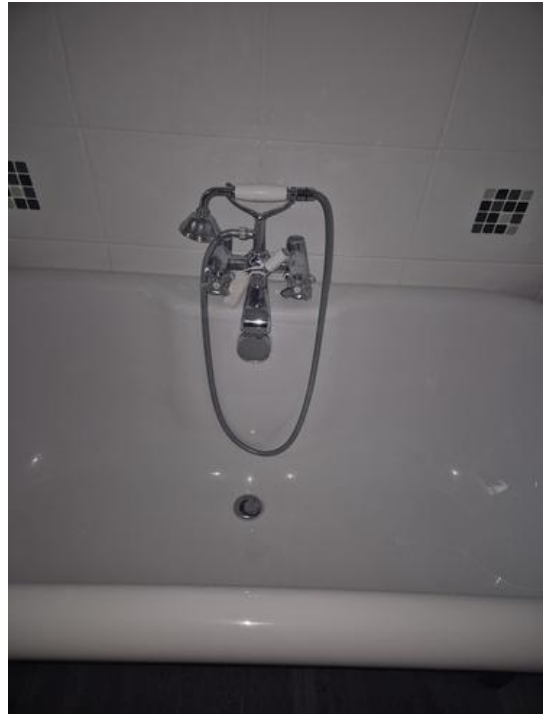
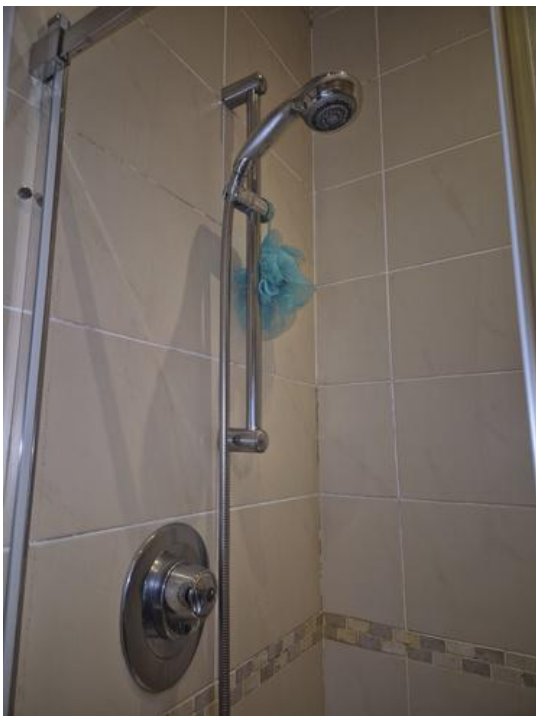
Shower heads	
Are there any showers in the property?	Yes
Take photo of shower location
