**SHEPHERD**  
**HOME REPORT**

FLAT 2/2  
14 ARNPRIOR QUADRANT  
GLASGOW  
G45 9EZ

# Scottish Single Survey

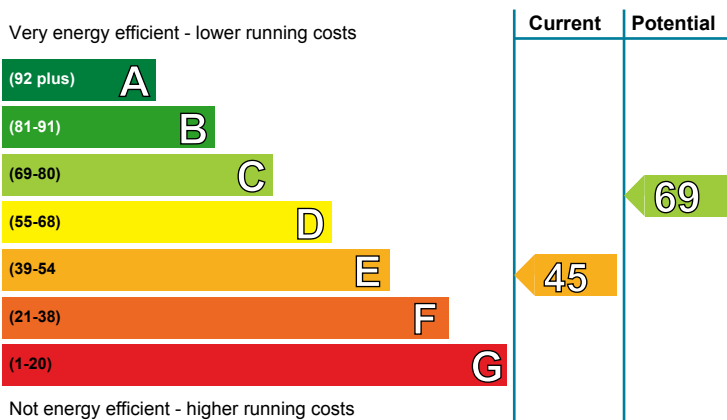
## Energy Efficiency Rating

Your current rating is **band E (45)**. The average rating for EPCs in Scotland is **band D (61)**.

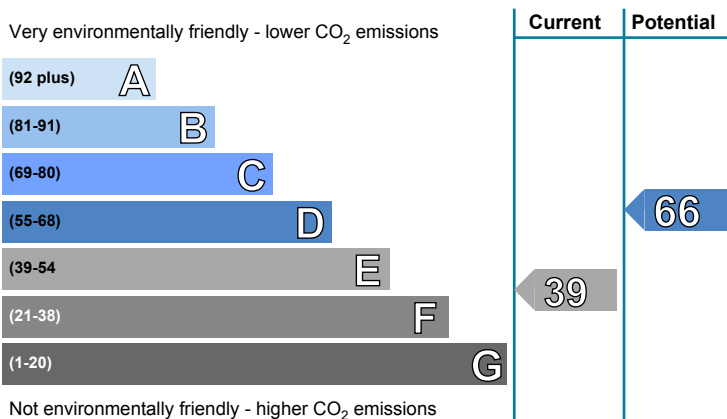
## Environmental Impact (CO<sub>2</sub>) Rating

Your current rating is **band E (39)**. The average rating for EPCs in Scotland is **band D (59)**.
