Shepherd Chartered Surveyors

SHEPHERD
HOME REPORT

Flat C 19 MARISCHAL STREET

ABERDEEN
AB11 5AD

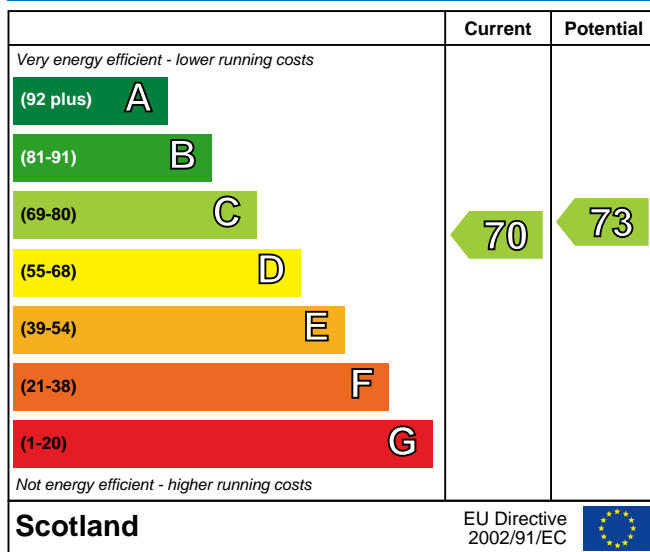
Energy Efficiency Rating

The energy efficiency rating is a measure of the overall efficiency of a home. The higher the rating the more energy efficient the home is and the lower the fuel bills are likely to be.

Approximate current energy use per square metre of floor area: 383 kWh/m² per year

Buildings that are more energy efficient use less energy, save money and help protect the environment. A building with a rating of 100 would cost almost nothing to heat and light and would cause almost no carbon emissions. The potential ratings in the certificate describe how close this building could get to 100 if all the cost effective recommended improvements were implemented.

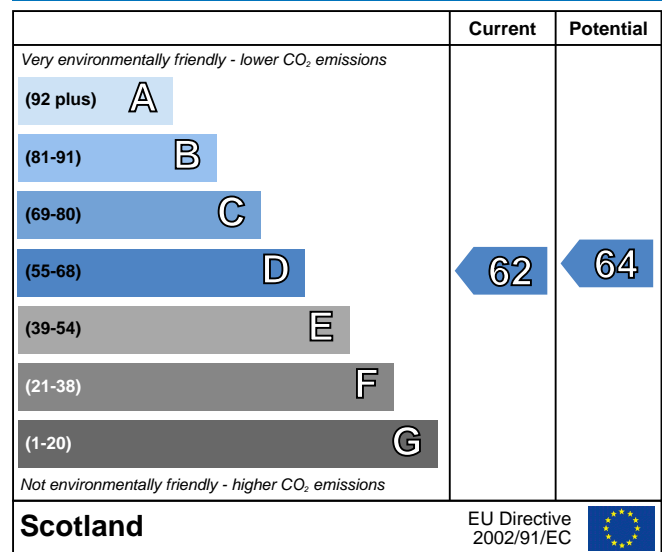
Environmental Impact (CO₂) Rating

Approximate current CO₂ emissions: 68 kg/m² per year

The environmental impact rating is a measure of a home's impact on the environment in terms of carbon dioxide (CO₂) emissions. The higher the rating the less impact it has on the environment.
