survey report on:

| Property address | 47 PF4 Spey Terrace Edinburgh EH7 4PU |
| Prepared by | Graham & Sibbald, Chartered Surveyors |

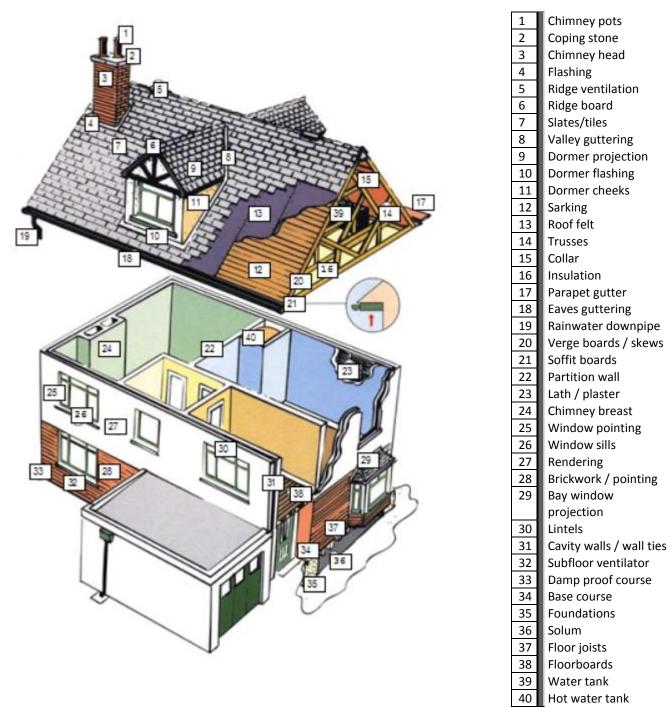
Sectional Diagram showing elements of a typical house

Reference may be made in this report to some or all of the above component parts of the property. This diagram may assist you in locating and understanding these items.
