HOME REPORT

MIRAMAR LOWER WEST FLAT, MARKETGATE, CRAIL, ANSTRUTHER, KY10 3TJ

Dwelling type:	Ground-floor flat	Reference number:	0186-1046-4234-0277-4920
Date of assessment:	08 April 2013	Type of assessment:	RdSAP, existing dwelling
Date of certificate:	08 April 2013	Primary Energy Indicator:	353 kWh/m ² /year
Total floor area:	78 m ²	Main heating and fuel:	Boiler and radiators, mains gas

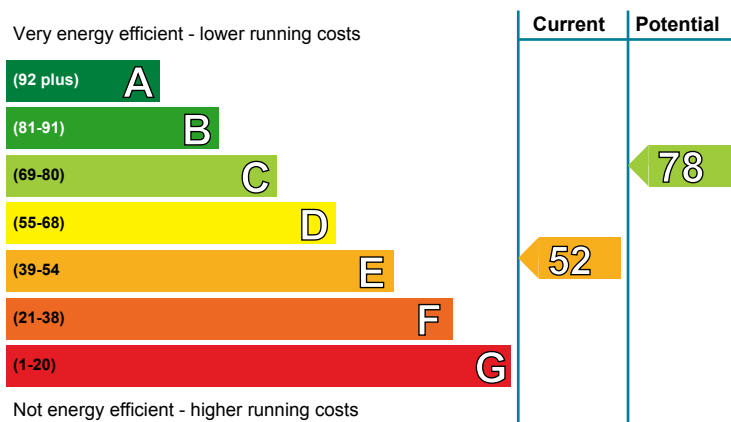
Energy Efficiency Rating

This graph shows the current efficiency of your home, taking into account both energy efficiency and fuel costs. The higher this rating, the lower your fuel bills are likely to be.

Your current rating is **band E (52)**. The average rating for a home in Scotland is **band D (61)**.

The potential rating shows the effect of undertaking all of the improvement measures listed within your recommendations report.

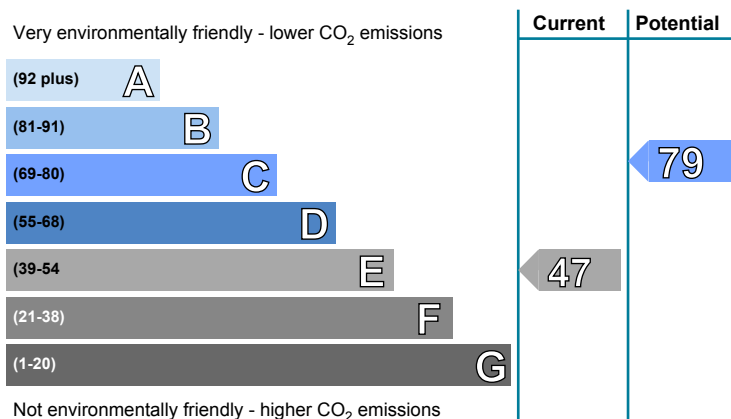
Environmental Impact (CO₂) Rating

This graph shows the effect of your home on the environment in terms of carbon dioxide (CO₂) emissions. The higher the rating, the less impact it has on the environment.

Your current rating is **band E (47)**. The average rating for a home in Scotland is **band D (59)**.

The potential rating shows the effect of undertaking all of the improvement measures listed within your recommendations report.
