# HOME REPORT

# Energy Performance Certificate (EPC)

FLAT 3/2 , 91 BARLOGAN AVENUE, GLASGOW, G52 1AG

**Dwelling type:** Top-floor flat  
**Date of assessment:** 24 May 2018  
**Date of certificate:** 29 May 2018  
**Total floor area:** 40 m<sup>2</sup>  
**Primary Energy Indicator:** 306 kWh/m<sup>2</sup>/year

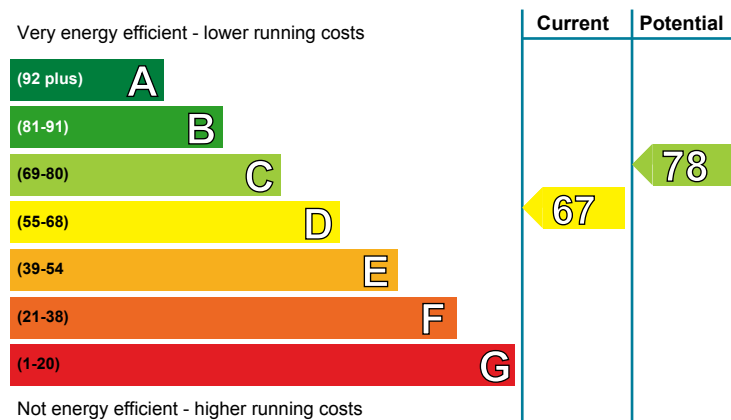
## Energy Efficiency Rating

This graph shows the current efficiency of your home, taking into account both energy efficiency and fuel costs. The higher this rating, the lower your fuel bills are likely to be.

Your current rating is **band D (67)**. The average rating for EPCs in Scotland is **band D (61)**.

The potential rating shows the effect of undertaking all of the improvement measures listed within your recommendations report.

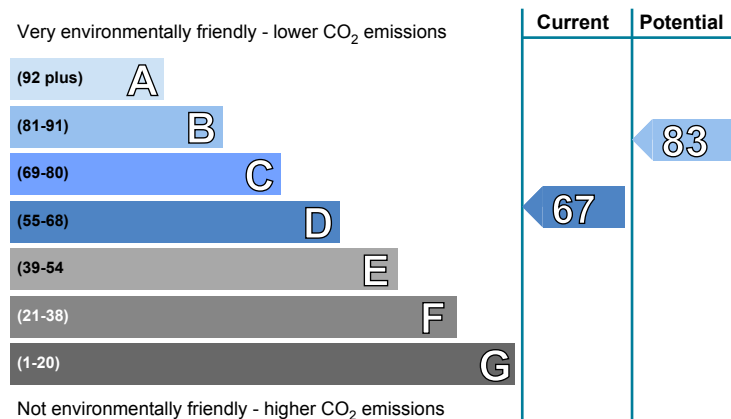
## Environmental Impact (CO<sub>2</sub>) Rating

This graph shows the effect of your home on the environment in terms of carbon dioxide (CO<sub>2</sub>) emissions. The higher the rating, the less impact it has on the environment.

Your current rating is **band D (67)**. The average rating for EPCs in Scotland is **band D (59)**.

The potential rating shows the effect of undertaking all of the improvement measures listed within your recommendations report.

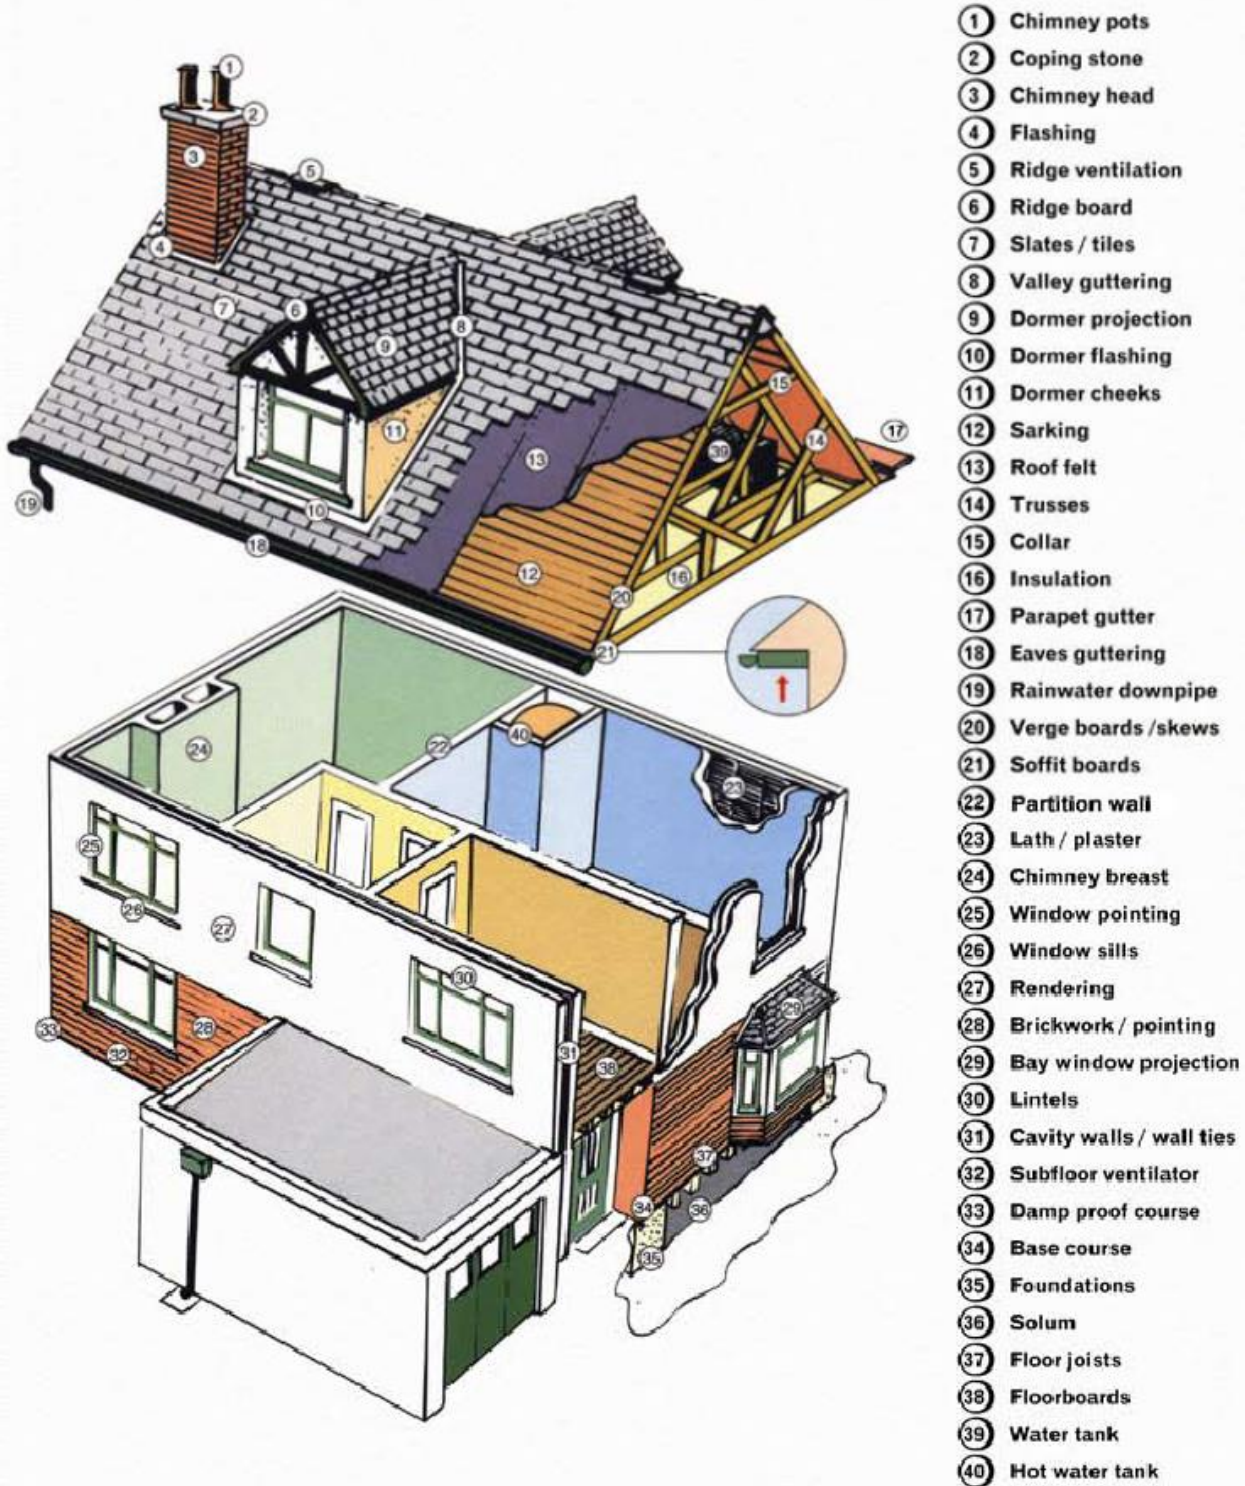
## Sectional Diagram showing elements of a typical house

Reference may be made in this report to some or all of the above component parts of the property. This diagram may assist you in locating and understanding these items.
