HOME report

SINGLE SURVEY
ENERGY REPORT
PROPERTY QUESTIONNAIRE
VALUATION REPORT

Single Survey

Property address	Flat C, 58 Charlotte Street, Aberdeen, AB25 1LT
------------------	--

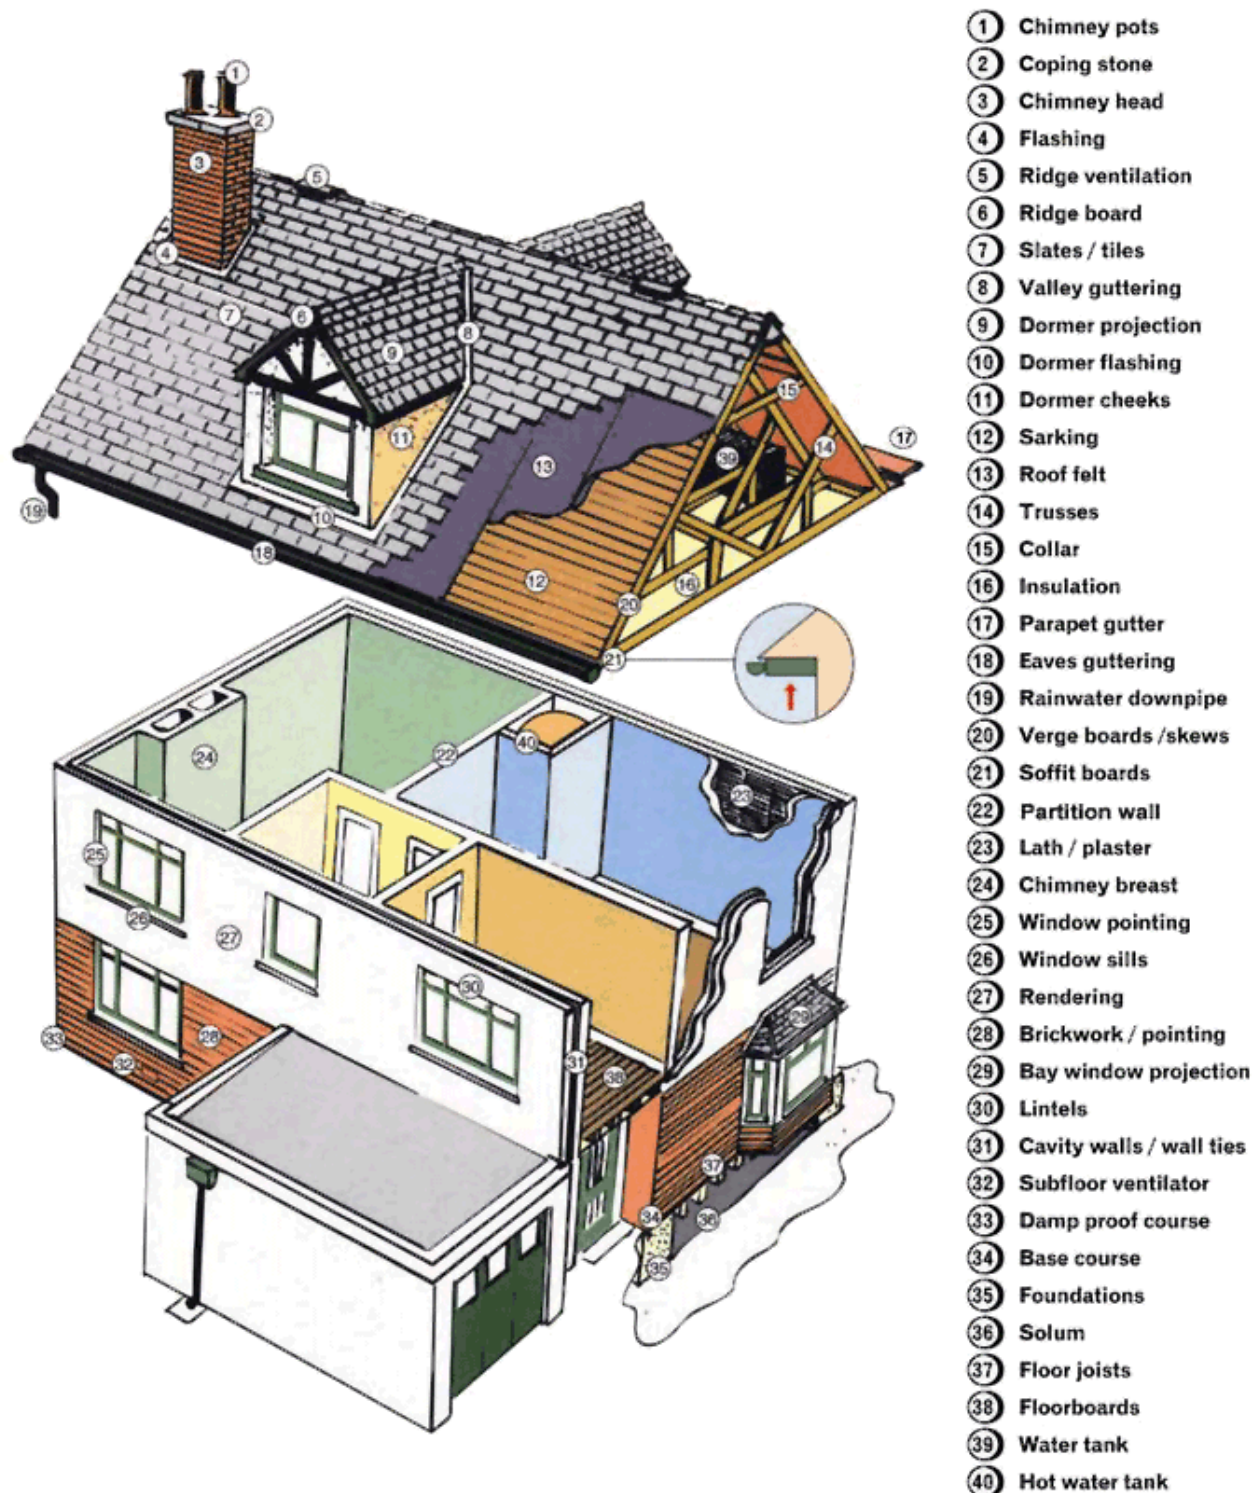
Sectional Diagram showing elements of a typical house

Reference may be made in this report to some or all of the above component parts of the property. This diagram may assist you in locating and understanding these items.
