YOUR ONESURVEY  
**HOME REPORT**

Flat 0/2  
4 Normal Avenue  
Jordanhill  
Glasgow  
G13 1FD

# SINGLE SURVEY

A report on the condition of the property, with categories being rated from 1 to 3.

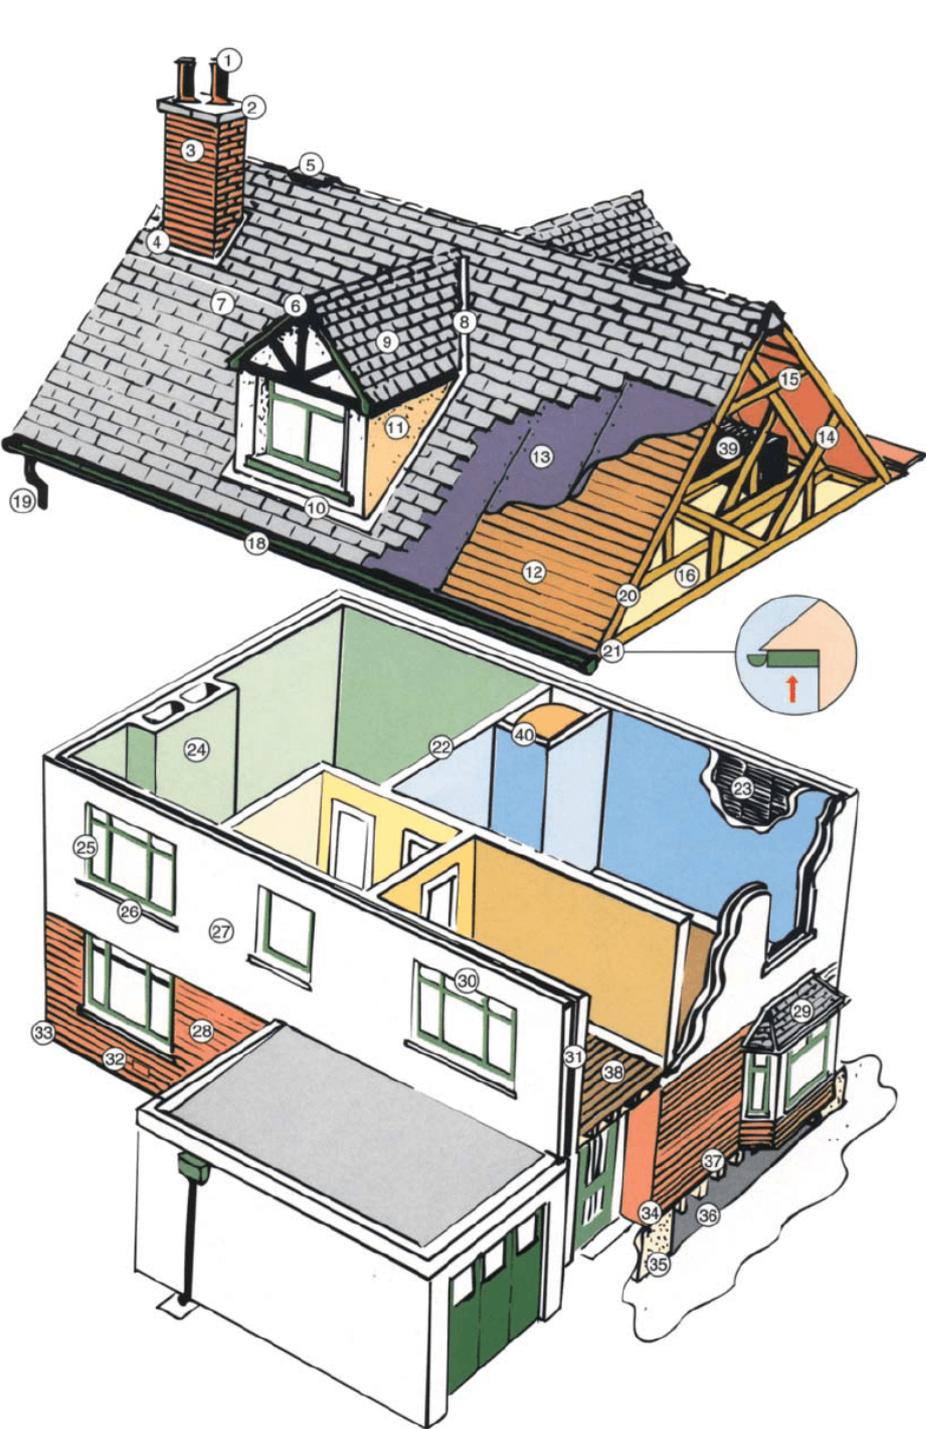
# Sectional Diagram showing elements of a typical house

- ① Chimney pots
- ② Coping stone
- ③ Chimney head
- ④ Flashing
- ⑤ Ridge ventilation
- ⑥ Ridge board
- ⑦ Slates / tiles
- ⑧ Valley guttering
- ⑨ Dormer projection
- ⑩ Dormer flashing
- ⑪ Dormer cheeks
- ⑫ Sarking
- ⑬ Roof felt
- ⑭ Trusses
- ⑮ Collar
- ⑯ Insulation
- ⑰ Parapet gutter
- ⑱ Eaves guttering
- ⑲ Rainwater downpipe
- ⑳ Verge boards /skews
- ㉑ Soffit boards
- ㉒ Partiton wall
- ㉓ Lath / plaster
- ㉔ Chimney breast
- ㉕ Window pointing
- ㉖ Window sills
- ㉗ Rendering
- ㉘ Brickwork / pointing
- ㉙ Bay window projection
- ㉚ Lintels
- ㉛ Cavity walls / wall ties
- ㉜ Subfloor ventilator
- ㉝ Damp proof course
- ㉞ Base course
- ㉟ Foundations
- ㊱ Solum
- ㊲ Floor joists
- ㊳ Floorboards
- ㊴ Water tank
- ㊵ Hot water tank

Reference may be made in this report to some or all of the above component parts of the property. This diagram may assist you in locating and understanding these items.

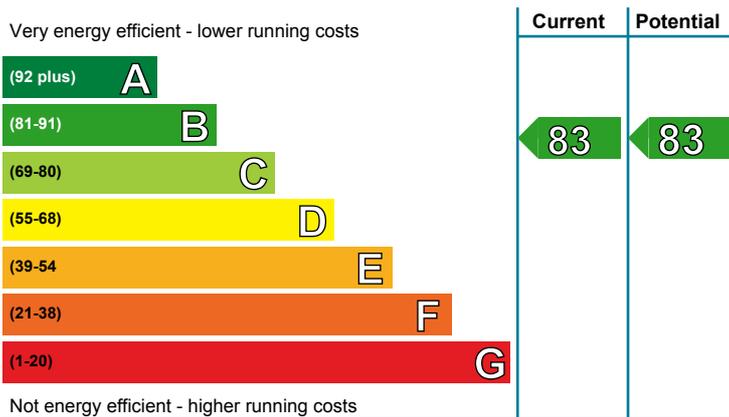
## Energy Efficiency Rating

This graph shows the current efficiency of your home, taking into account both energy efficiency and fuel costs. The higher this rating, the lower your fuel bills are likely to be.

Your current rating is **band B (83)**. The average rating for EPCs in Scotland is **band D (61)**.

The potential rating shows the effect of undertaking all of the improvement measures listed within your recommendations report.

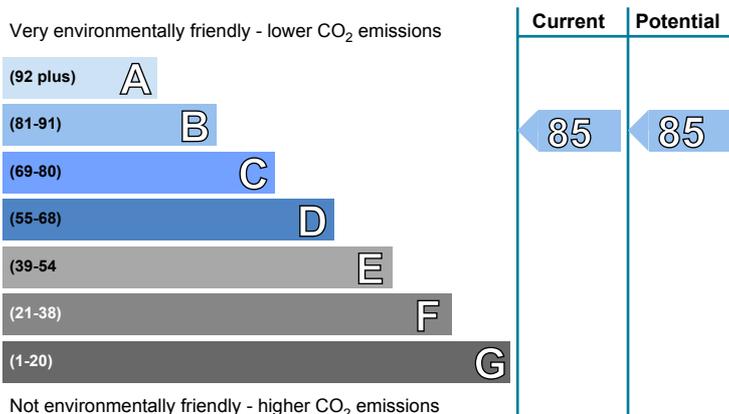
## Environmental Impact (CO<sub>2</sub>) Rating

This graph shows the effect of your home on the environment in terms of carbon dioxide (CO<sub>2</sub>) emissions. The higher the rating, the less impact it has on the environment.
