survey report on:

Property address	Flat 11 22 Springwell Place Edinburgh EH11 2HY
Customer	Miss M Munro

Prepared by J & E Shepherd

Pate of inspection	15th July 2015
--------------------	----------------

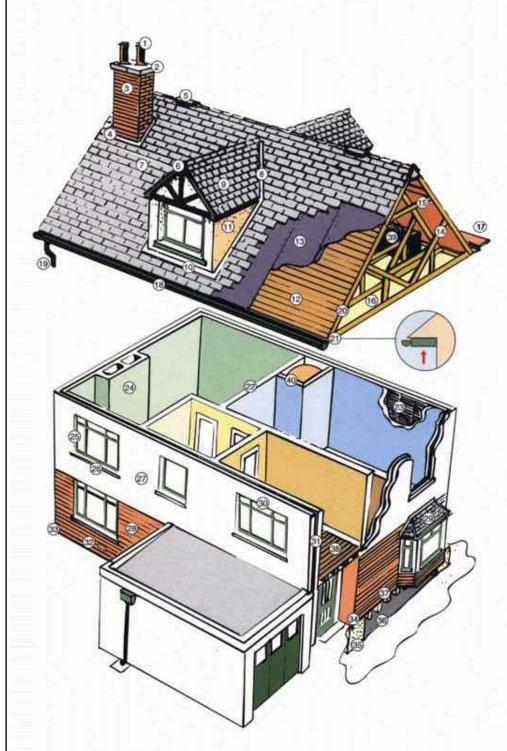
Sectional Diagram showing elements of a typical house

Reference may be made in this report to some or all of the above component parts of the property. This diagram may assist you in locating and understanding these items.

- 1) Chimney pots
- 2 Coping stone
- 3) Chimney head
- 4) Flashing
- (5) Ridge ventilation
- 6) Ridge board
- 7) Slates / tiles
- (8) Valley guttering
- 9) Dormer projection
- (10) Dormer flashing
- 11) Dormer cheeks
- (12) Sarking
- (13) Roof felt
- (14) Trusses
- 15) Collar
- (16) Insulation
 - 7) Parapet gutter
- 18) Eaves guttering
- 19) Rainwater downpipe
- O Verge boards /skews
- (21) Soffit boards
- 22) Partition wall
- 3 Lath / plaster
- (24) Chimney breast
- 25) Window pointing
- (6) Window sills
- (27) Rendering
- (28) Brickwork / pointing
- (29) Bay window projection
- (30) Lintels
- (31) Cavity walls / wall ties
- 32) Subfloor ventilator
- 33) Damp proof course
- 34) Base course
- 35) Foundations
- 36) Solum
- Floor joists
- 38) Floorboards
- 39) Water tank
- 40 Hot water tank
