HOME report

SINGLE SURVEY
ENERGY REPORT
PROPERTY QUESTIONNAIRE
VALUATION REPORT

Property address	Flat 2/1, 924 Govan Road, Glasgow, G51 3AF
-------------------------	---

Prepared by	Harvey Donaldson And Gibson
--------------------	-----------------------------

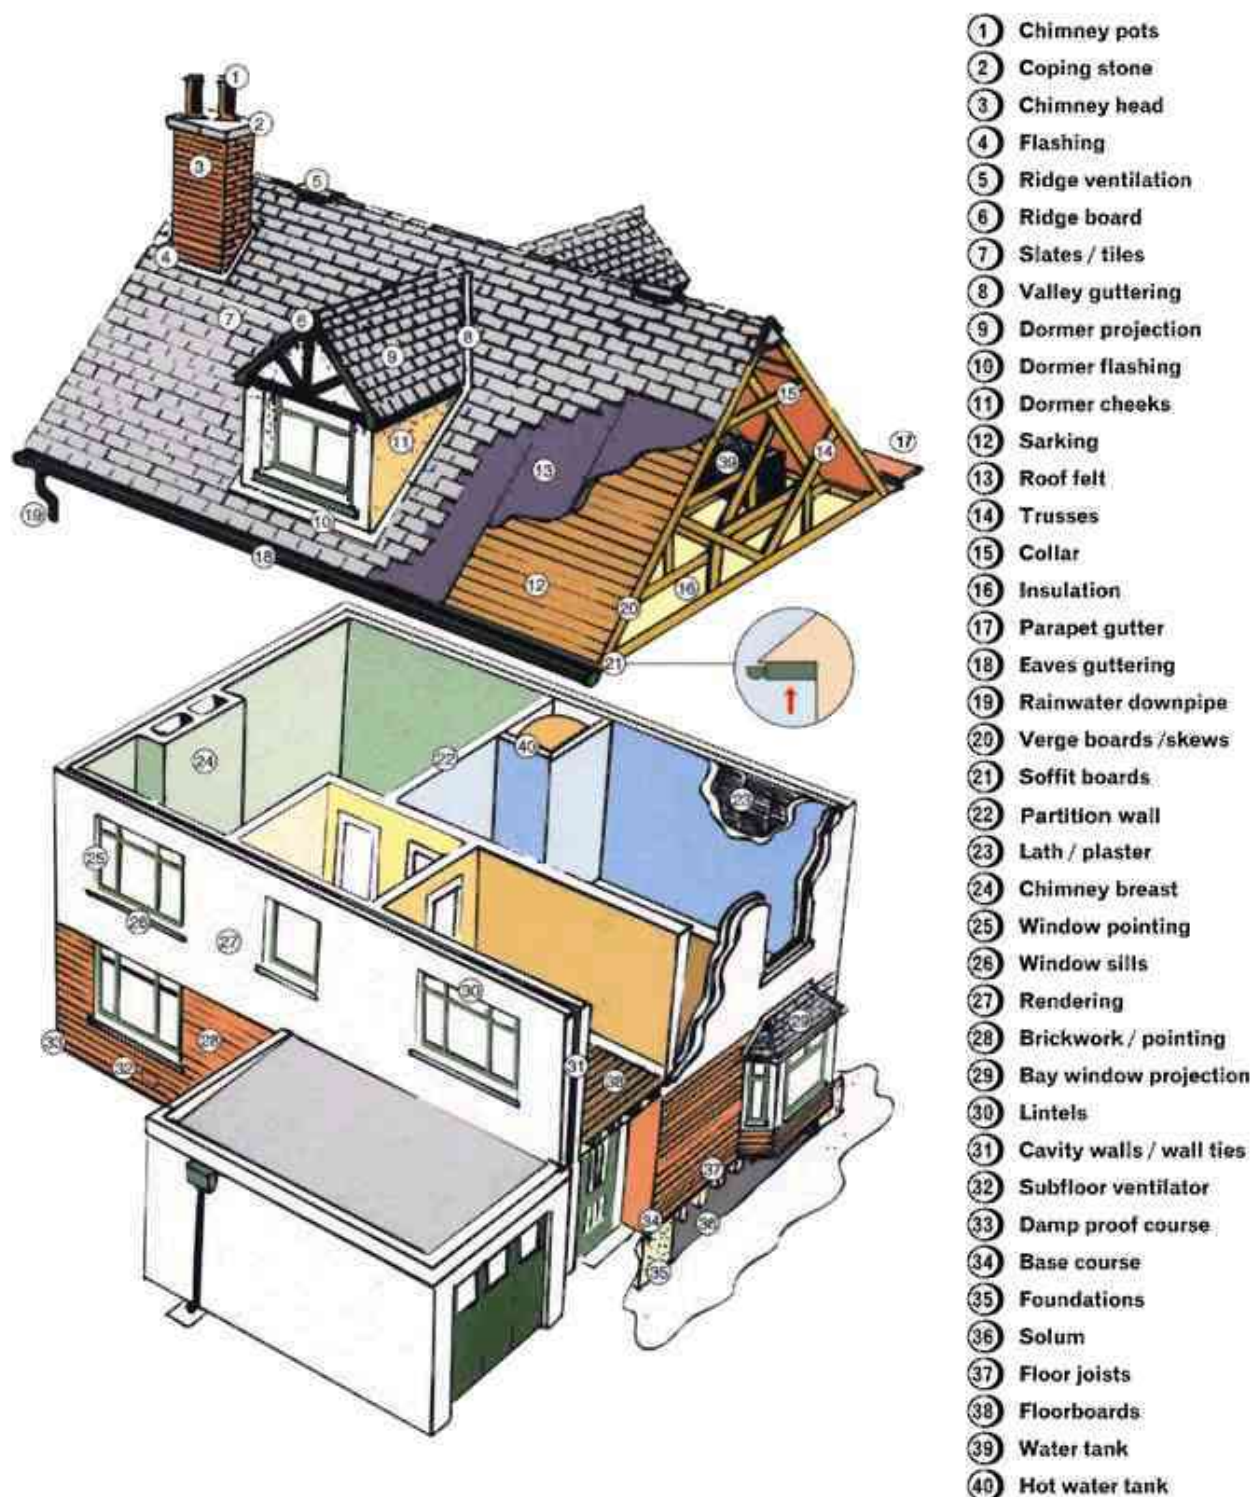
Sectional Diagram showing elements of a typical house

Reference may be made in this report to some or all of the above component parts of the property. This diagram may assist you in locating and understanding these items.

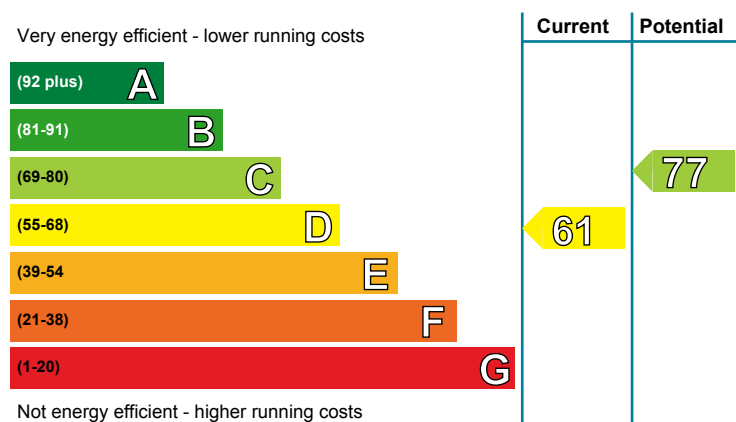
Energy Efficiency Rating

This graph shows the current efficiency of your home, taking into account both energy efficiency and fuel costs. The higher this rating, the lower your fuel bills are likely to be.

Based on calculated energy use of **320 kWh/m²/yr**, your current rating is **band D (61)**. The average rating for a home in Scotland is **band D (61)**.

The potential rating shows the effect of undertaking all of the improvement measures listed within your recommendations report.

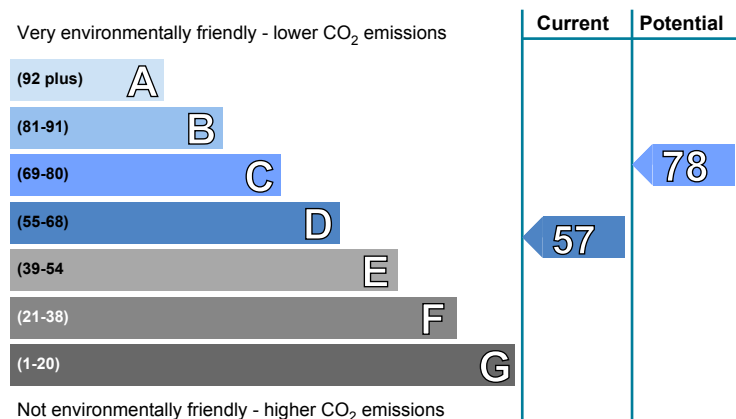
Environmental Impact (CO₂) Rating

This graph shows the effect of your home on the environment in terms of carbon dioxide (CO₂) emissions. The higher the rating, the less impact it has on the environment.
