espc:home report

3/5 Mertoun Place
EDINBURGH
EH11 1JU
28/09/2018

Single Survey

Property address	3F1, 3 Mertoun Place, Edinburgh, EH11 1JU
-------------------------	--

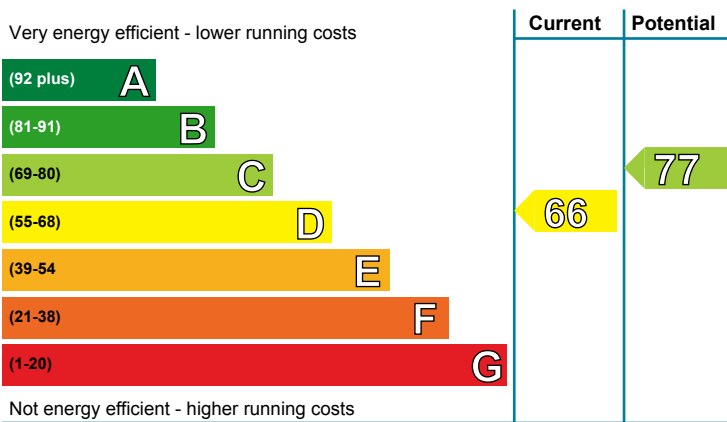
Energy Efficiency Rating

This graph shows the current efficiency of your home, taking into account both energy efficiency and fuel costs. The higher this rating, the lower your fuel bills are likely to be.

Your current rating is **band D (66)**. The average rating for EPCs in Scotland is **band D (61)**.

The potential rating shows the effect of undertaking all of the improvement measures listed within your recommendations report.

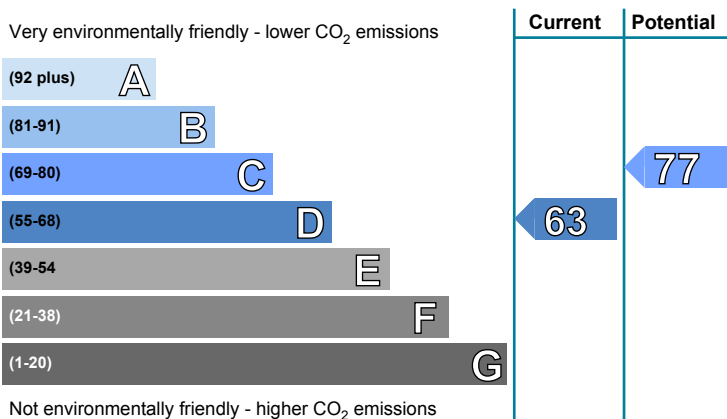
Environmental Impact (CO₂) Rating

This graph shows the effect of your home on the environment in terms of carbon dioxide (CO₂) emissions. The higher the rating, the less impact it has on the environment.

The potential rating shows the effect of undertaking all of the improvement measures listed within your recommendations report.
