FLAT 2/1
201 COPLAND ROAD
GLASGOW
G51 2UT

Home Report

Scottish Single Survey

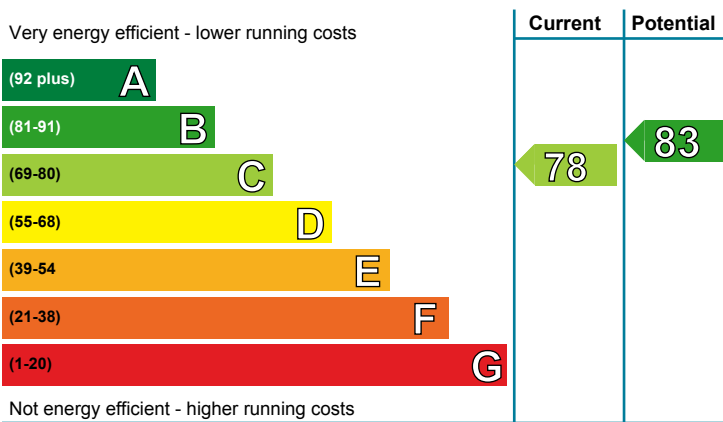
Energy Efficiency Rating

This graph shows the current efficiency of your home, taking into account both energy efficiency and fuel costs. The higher this rating, the lower your fuel bills are likely to be.

Your current rating is **band C (78)**. The average rating for EPCs in Scotland is **band D (61)**.

The potential rating shows the effect of undertaking all of the improvement measures listed within your recommendations report.

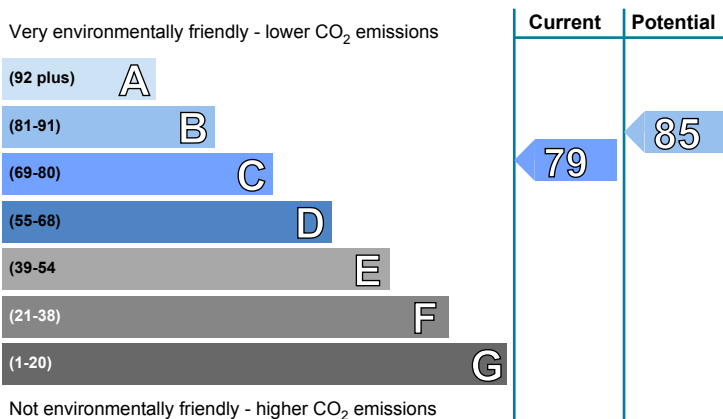
Environmental Impact (CO₂) Rating

This graph shows the effect of your home on the environment in terms of carbon dioxide (CO₂) emissions. The higher the rating, the less impact it has on the environment.

Your current rating is **band C (79)**. The average rating for EPCs in Scotland is **band D (59)**.

The potential rating shows the effect of undertaking all of the improvement measures listed within your recommendations report.
