## Mortgage Valuation Reports for Purchasers

# Single Survey Report

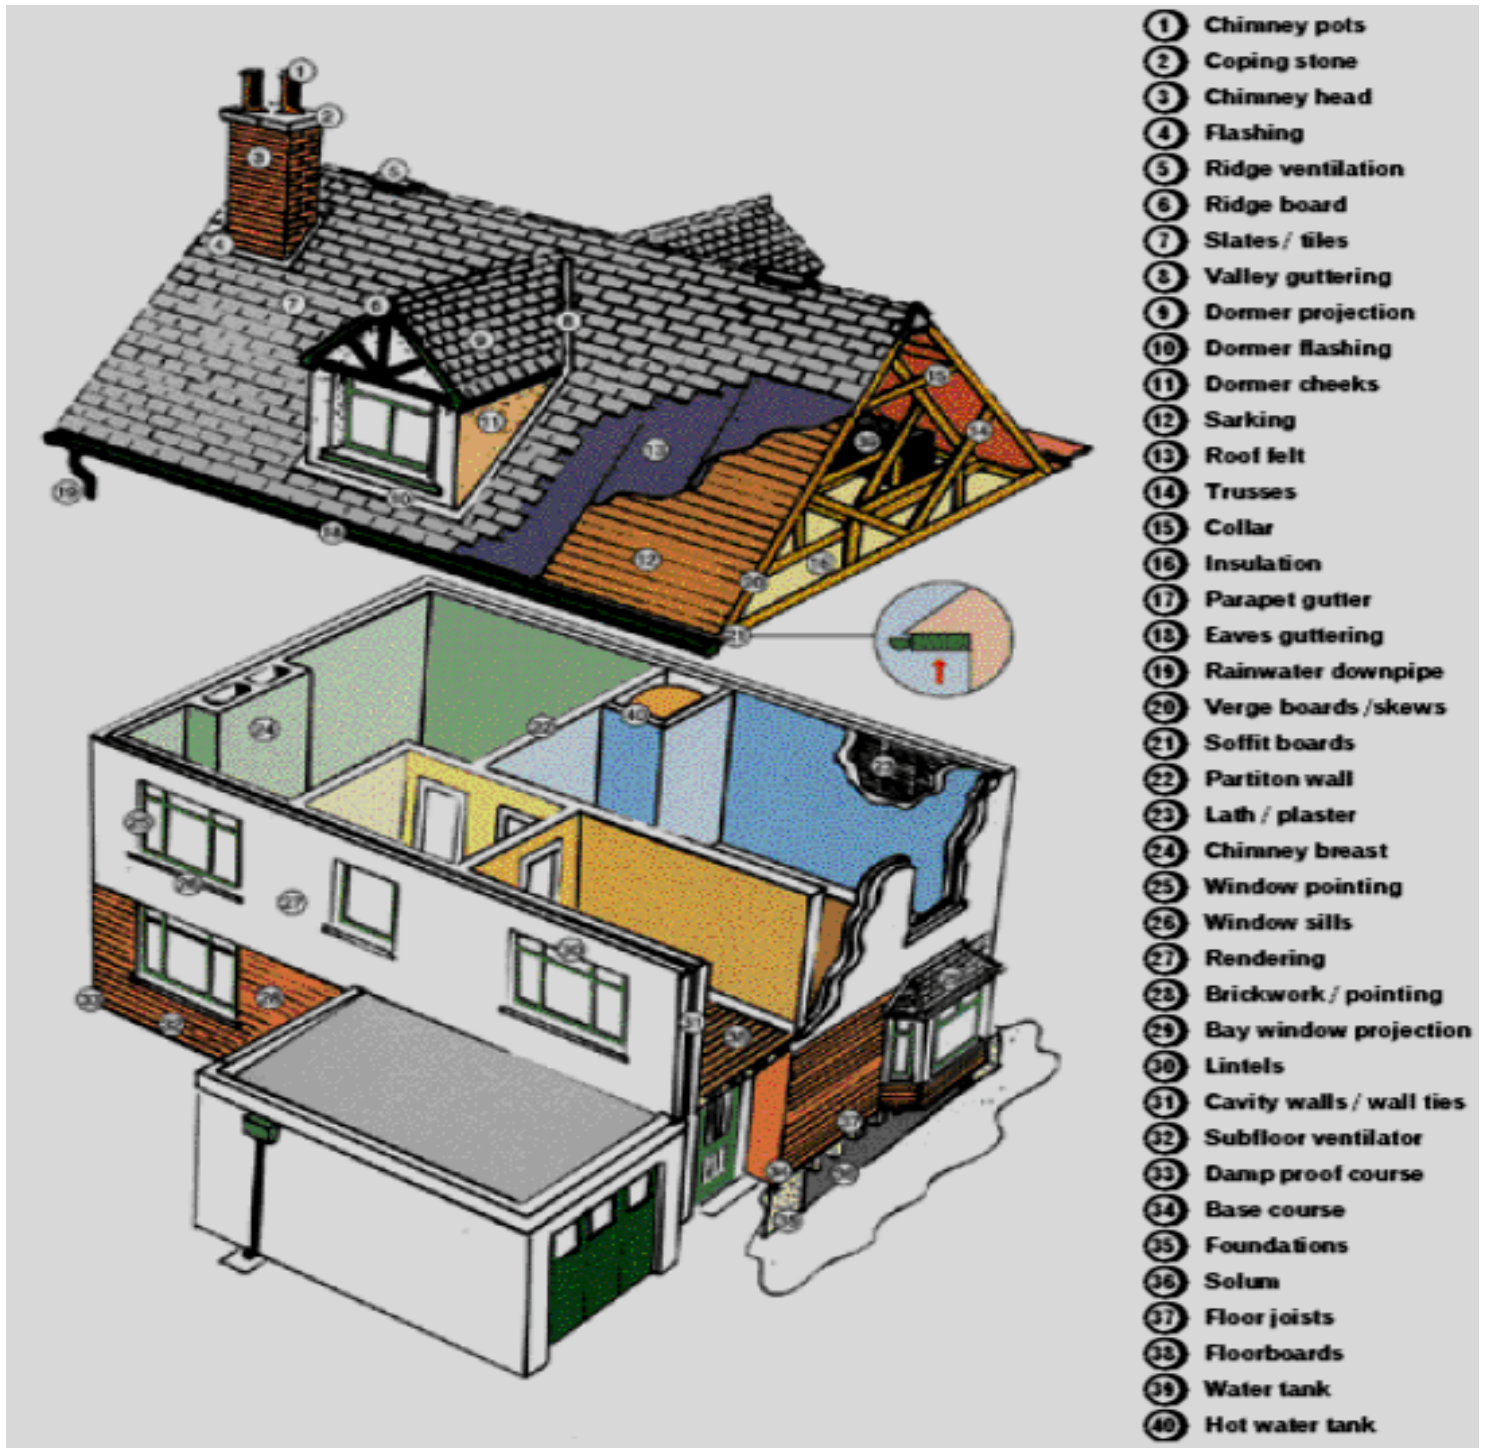
## Sectional diagram showing elements of a typical house

Reference may be made in this report to some or all of the above component parts of the property. This diagram may assist you in locating and understanding these terms.
