# espc:home report

# Single Survey

<b>Property address</b>	2F1 172 Dalkeith Road Edinburgh EH16 5DX
-------------------------	---

<b>Prepared by</b>	Graham + Sibbald
--------------------	------------------

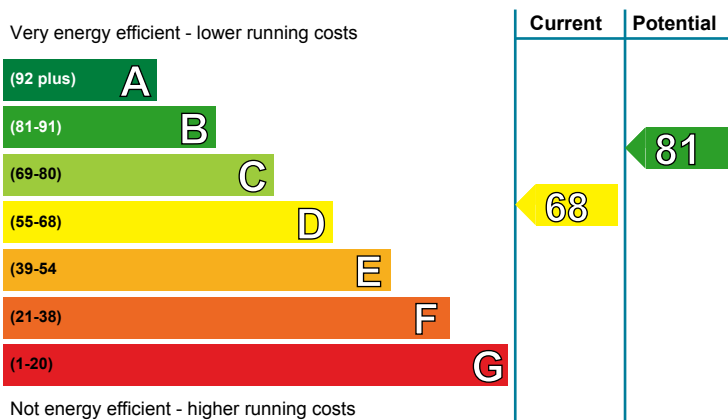
## Energy Efficiency Rating

This graph shows the current efficiency of your home, taking into account both energy efficiency and fuel costs. The higher this rating, the lower your fuel bills are likely to be.

Your current rating is **band D (68)**. The average rating for EPCs in Scotland is **band D (61)**.

The potential rating shows the effect of undertaking all of the improvement measures listed within your recommendations report.
