# survey report on:

Property address	Flat 1 7 Magdala Crescent Edinburgh EH12 5BE
Customer	Mr & Mrs P Burbridge
Customer address	c/o HBJ Gateley 19 Canning Street Edinburgh EH3 8HE
Prepared by	J & E Shepherd
Date of inspection	6th January 2015

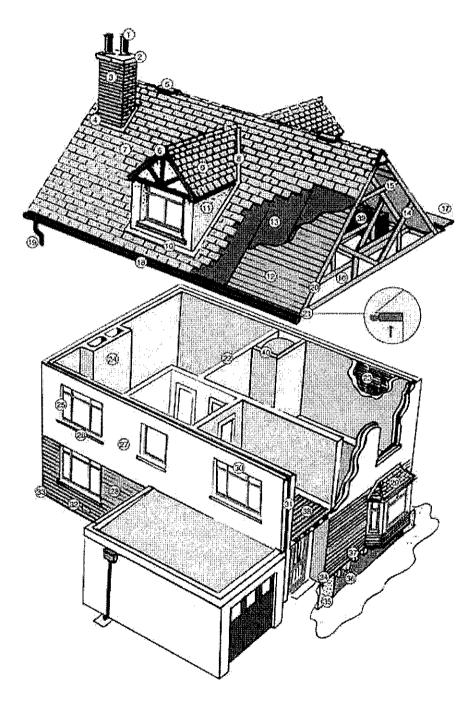
# Sectional Diagram showing elements of a typical house

Reference may be made in this report to some or all of the above component parts of the property. This diagram may assist you in locating and understanding these items.

- (1) Chimney pots
- (2) Coping stone
- (3) Chimney head
- (4) Flashing
- (5) Ridge ventilation
- Ridge board
- (7) Slates/tiles
- (8) Valley guttering
- (9) Dormer projection
- 10 Dormer flashing
- (11) Dormer cheeks
- (12) Sarking
- (13) Roof felt
- (14) Trusses
- (15) Collar
- (16) Insulation
- (17) Parapet gutter
- (8) Eaves guttering
- (19) Rainwater downpipe
- (20) Verne boards /skews
- (21) Soffit boards
- (22) Partition wall
- (23) Lath/plaster
- (24) Chimney breast
- 25) Window pointing
- (26) Window sills
- 27) Rendering
- (28) Brickwork / pointing
- (29) Bay window projection
- (30) Lintels
- (31) Cavity walls / wall ties
- (32) Subfloor ventilator
- (3) Damp proof course
- (34) Base course
- (35) Foundations
- (36) Solum
- 37 Floor joists
- (38) Floorboards:
- (39) Water tank
- (0) Hot water tank
