SINGLE SURVEY REPORT

25F NEWBIGGING MUSSELBURGH EAST LOTHIAN EH21 7AL

Date of inspection:

27 JANUARY 2015

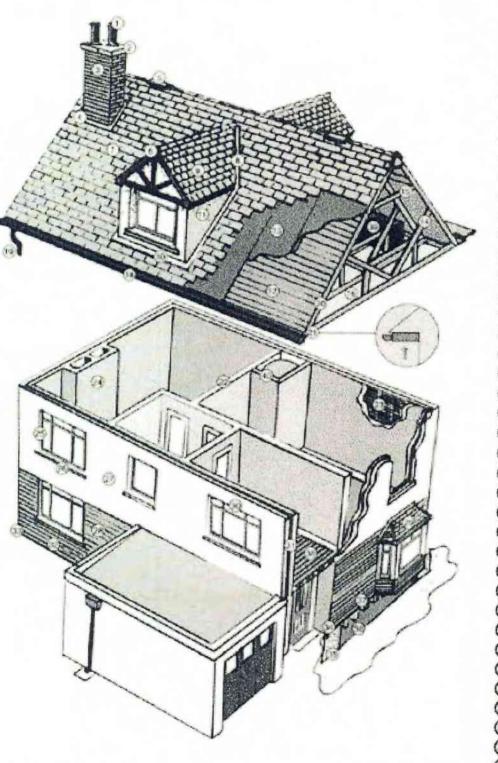
Sectional diagram showing elements of a typical house

Chimney pols \mathbf{G} Coping stone 2 Chimney head Flashing **Ridge ventilation** Ridge board Slates / tiles Valley guttering Dormer projection 1 10) Dormer flashing Dormer cheeks m Sarking 12 Roof left 13) Trusses Collar 15 Insulation Parapet outler Eaves guttering Rainwater downpipe Verge boards/skews Soffit boards Partiton wall 23) Lath / plaster Chimney breast Window pointing 26) Window sills Rendering Brickwork pointing 23) Bay window projection 29) Lintels (31) Cavity walls / wall ties Subfloor ventilator 3 Damp proof course Base course 6. Foundations (3) Solum **Floor** joists Floorboards Water tank Hot water tank

Reference may be made in this report to some or all of the above component parts of the property. This diagram may assist you in locating and understanding these terms.

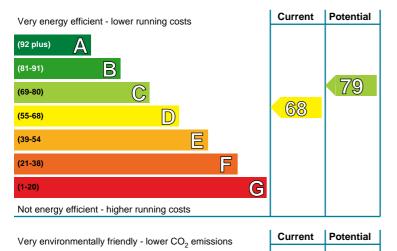
Energy Efficiency Rating

This graph shows the current efficiency of your home, taking into account both energy efficiency and fuel costs. The higher this rating, the lower your fuel bills are likely to be.
