survey report on:

_	27 /F C
Property address	37 /5 Springvalley Terrace
	Edinburgh
	EH10 4PZ
Customer	Iona Maltman
Customer	37 /5 Springvalley Terrace
address	Edinburgh
auuress	EH10 4PZ
Prepared by	Graham & Sibbald

1. Information and scope of inspection

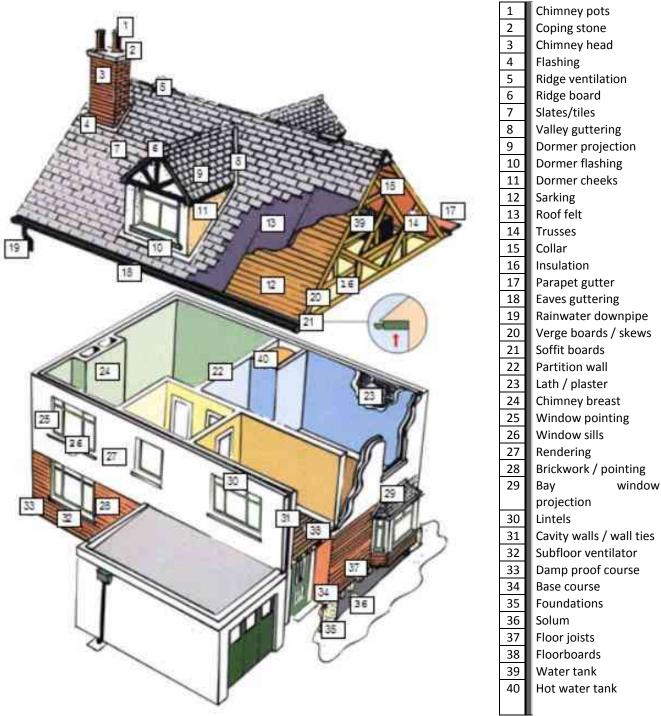
Sectional Diagram showing elements of a typical house

Reference may be made in this report to some or all of the above component parts of the property. This diagram may assist you in locating and understanding these items.
