**HOME**  
report

SINGLE SURVEY  
ENERGY REPORT  
PROPERTY QUESTIONNAIRE  
VALUATION REPORT

# Single Survey

<b>Property address</b>	226 Myreside Street, Glasgow, G32 6DX
-------------------------	---

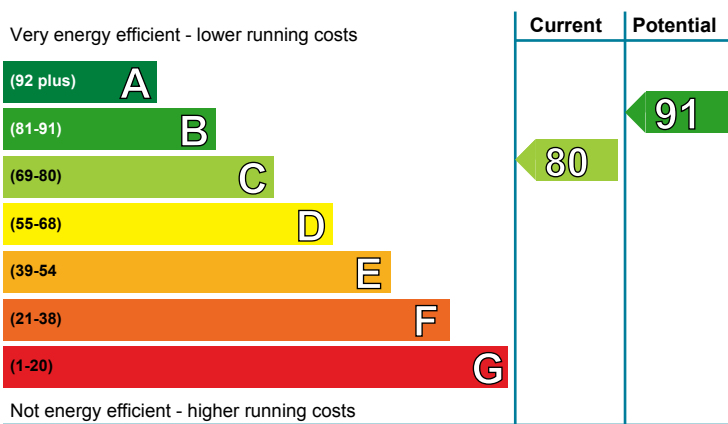
## Energy Efficiency Rating

This graph shows the current efficiency of your home, taking into account both energy efficiency and fuel costs. The higher this rating, the lower your fuel bills are likely to be.

Your current rating is **band C (80)**. The average rating for EPCs in Scotland is **band D (61)**.

The potential rating shows the effect of undertaking all of the improvement measures listed within your recommendations report.

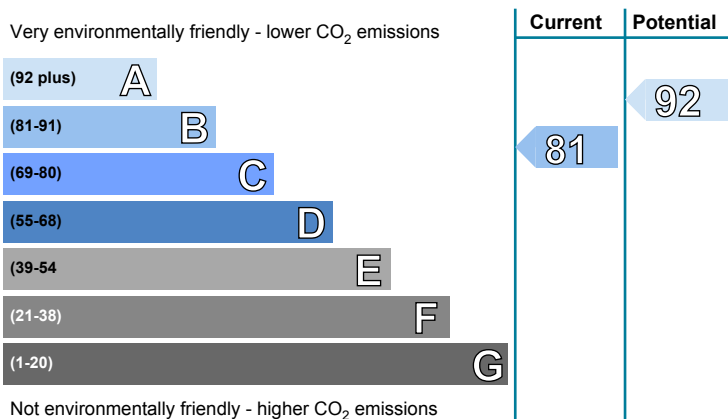
## Environmental Impact (CO<sub>2</sub>) Rating

This graph shows the effect of your home on the environment in terms of carbon dioxide (CO<sub>2</sub>) emissions. The higher the rating, the less impact it has on the environment.
