2/L, 131 Clepington Road Dundee DD3 7PA

home report index

single survey

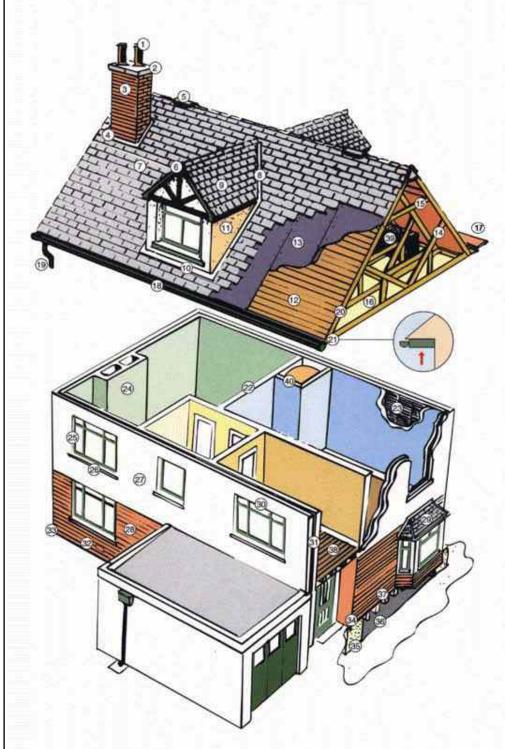
Sectional Diagram showing elements of a typical house

Reference may be made in this report to some or all of the above component parts of the property. This diagram may assist you in locating and understanding these items.

- 1 Chimney pots
- 2) Coping stone
- 3) Chimney head
- 4) Flashing
- 5 Ridge ventilation
- 6) Ridge board
- 7) Slates / tiles
- (8) Valley guttering
- 9 Dormer projection
- 10 Dormer flashing
- (11) Dormer cheeks
- (12) Sarking
- (13) Roof felt
- (14) Trusses
- 15) Collar
- (16) Insulation
- 17) Parapet gutter
- 18) Eaves guttering
- 19) Rainwater downpipe
- 0) Verge boards /skews
- (21) Soffit boards
- 22) Partition wall
- 23) Lath / plaster
- 24) Chimney breast
- (25) Window pointing
- S
- 26) Window sills
- (27) Rendering
- (28) Brickwork / pointing
- 29) Bay window projection
- (30) Lintels
- (31) Cavity walls / wall ties
- 32) Subfloor ventilator
- 33) Damp proof course
- 34) Base course
- 35) Foundations
- 36) Solum
- 37) Floor joists
- 38) Floorboards
- 39) Water tank
- 10) Hot water tank

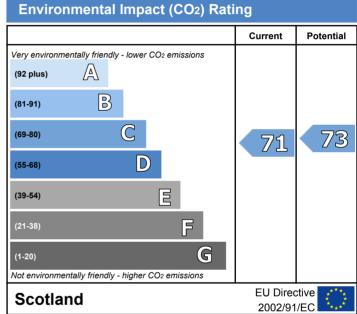
The environmental impact rating is a measure of a home's impact on the environment in terms of carbon dioxide (CO₂) emissions. The higher the rating the less impact it has on the environment.

Approximate current energy use per square metre of floor area: 233 kWh/m² per year Approximate current CO₂ emissions: 39 kg/m² per year
