SINGLE SURVEY

survey report on:

Property address	26 Milnacre Edinburgh EH6 5TD
Customer	Ms S Cann
Customer address	26 Milnacre Edinburgh EH6 5TD
	N: I D WDTCC
Prepared by	Nick Bonnar, MRICS

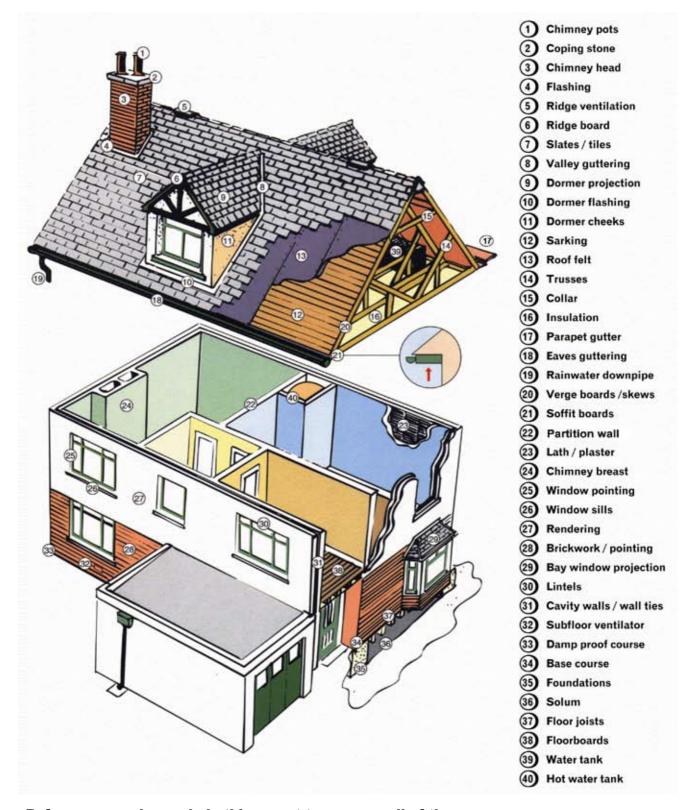
Sectional Diagram showing elements of a typical house

Reference may be made in this report to some or all of the above component parts of the property. This diagram may assist you in locating and understanding these items.
