## Legionella Risk Assessment

28  
Ferguson Court  
Aberdeen  
AB21 9AG

**Property type:** Flat

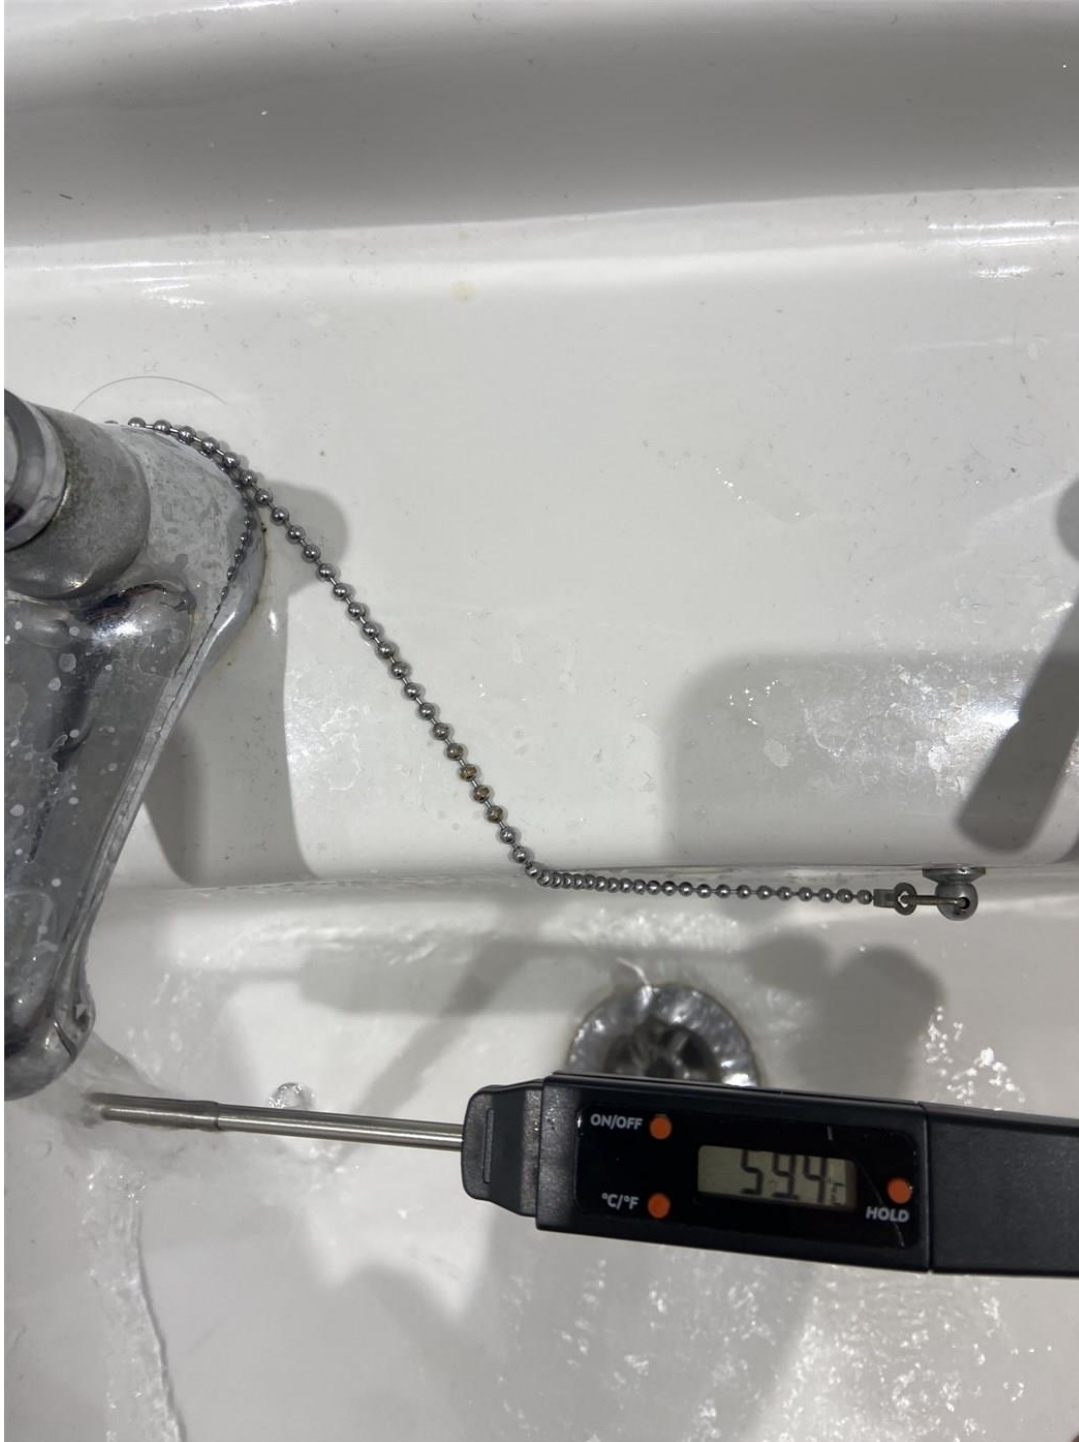
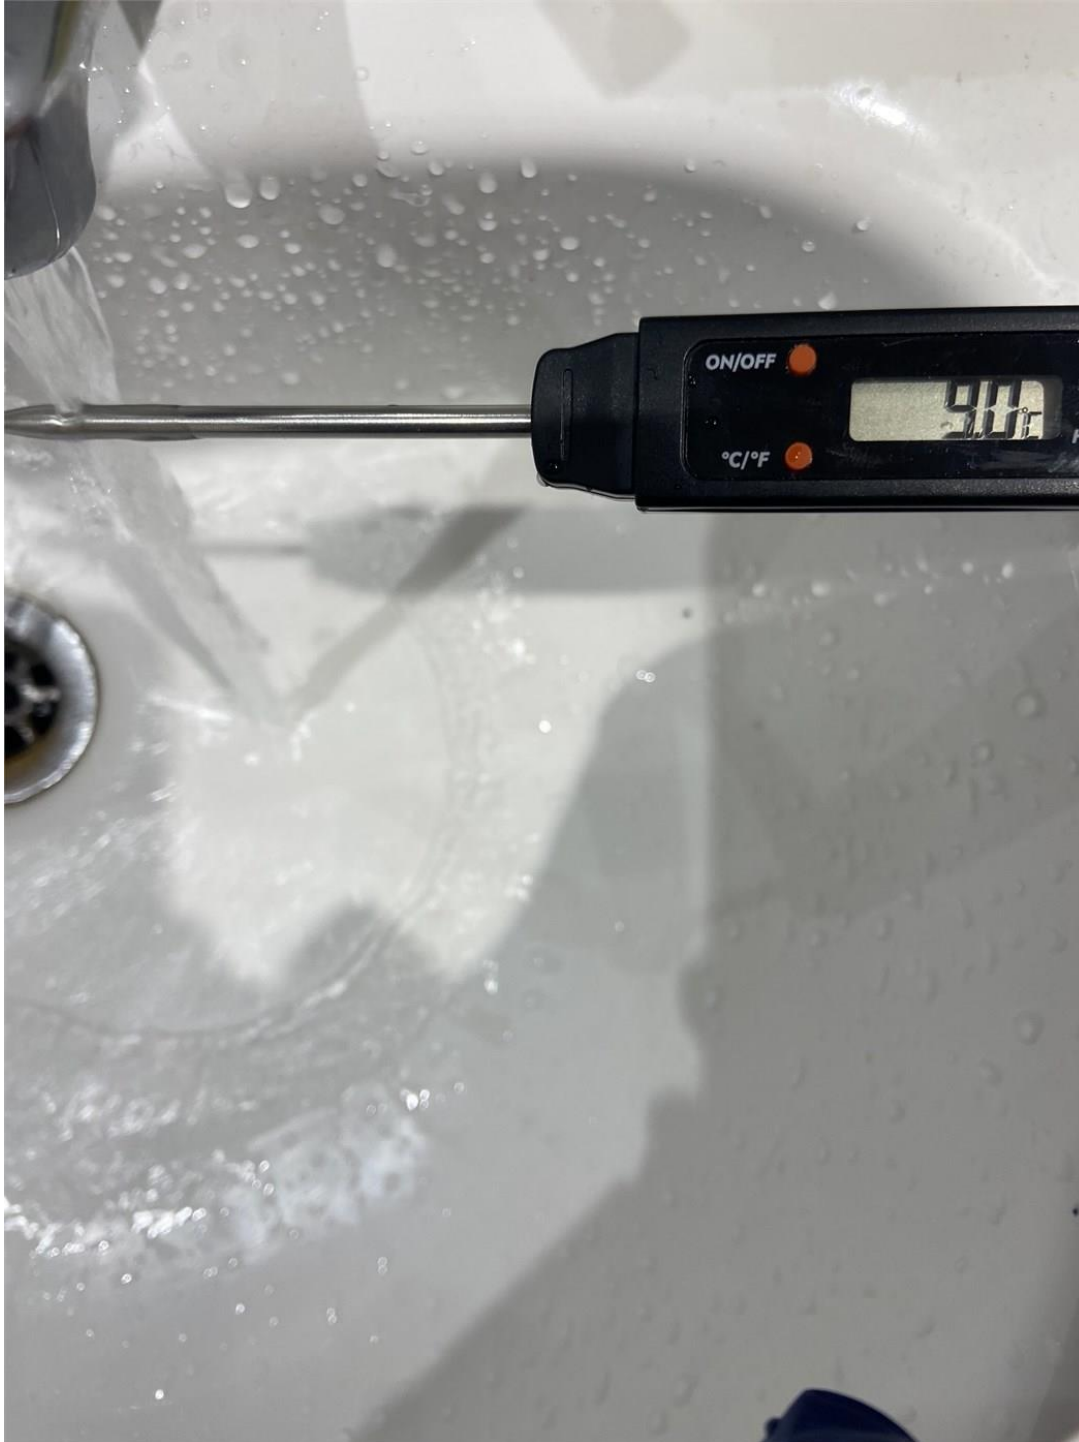
### Photo of water outlet

**Is cold water temperature below 20°C?** Yes

**Highest recorded temperature (°C)** 9

**Is hot water temperature above 50°C at outlets?** Yes

**Lowest recorded temperature(°C)** 59

**Are TMV's present?** No

**Risk level** 0 - None

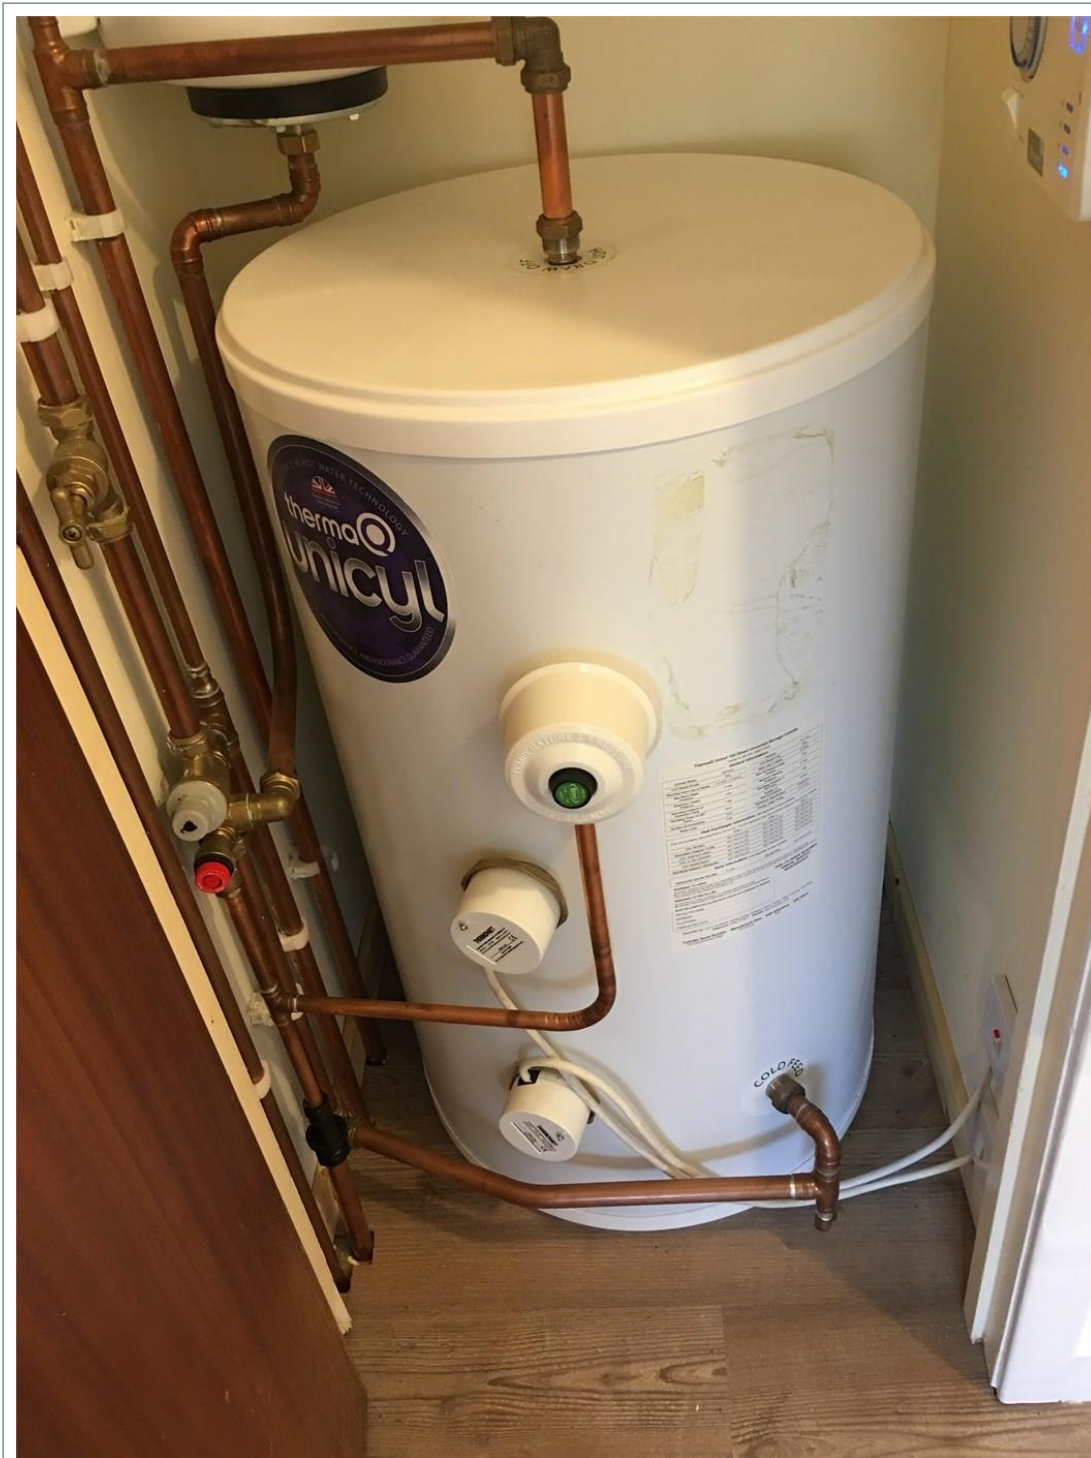
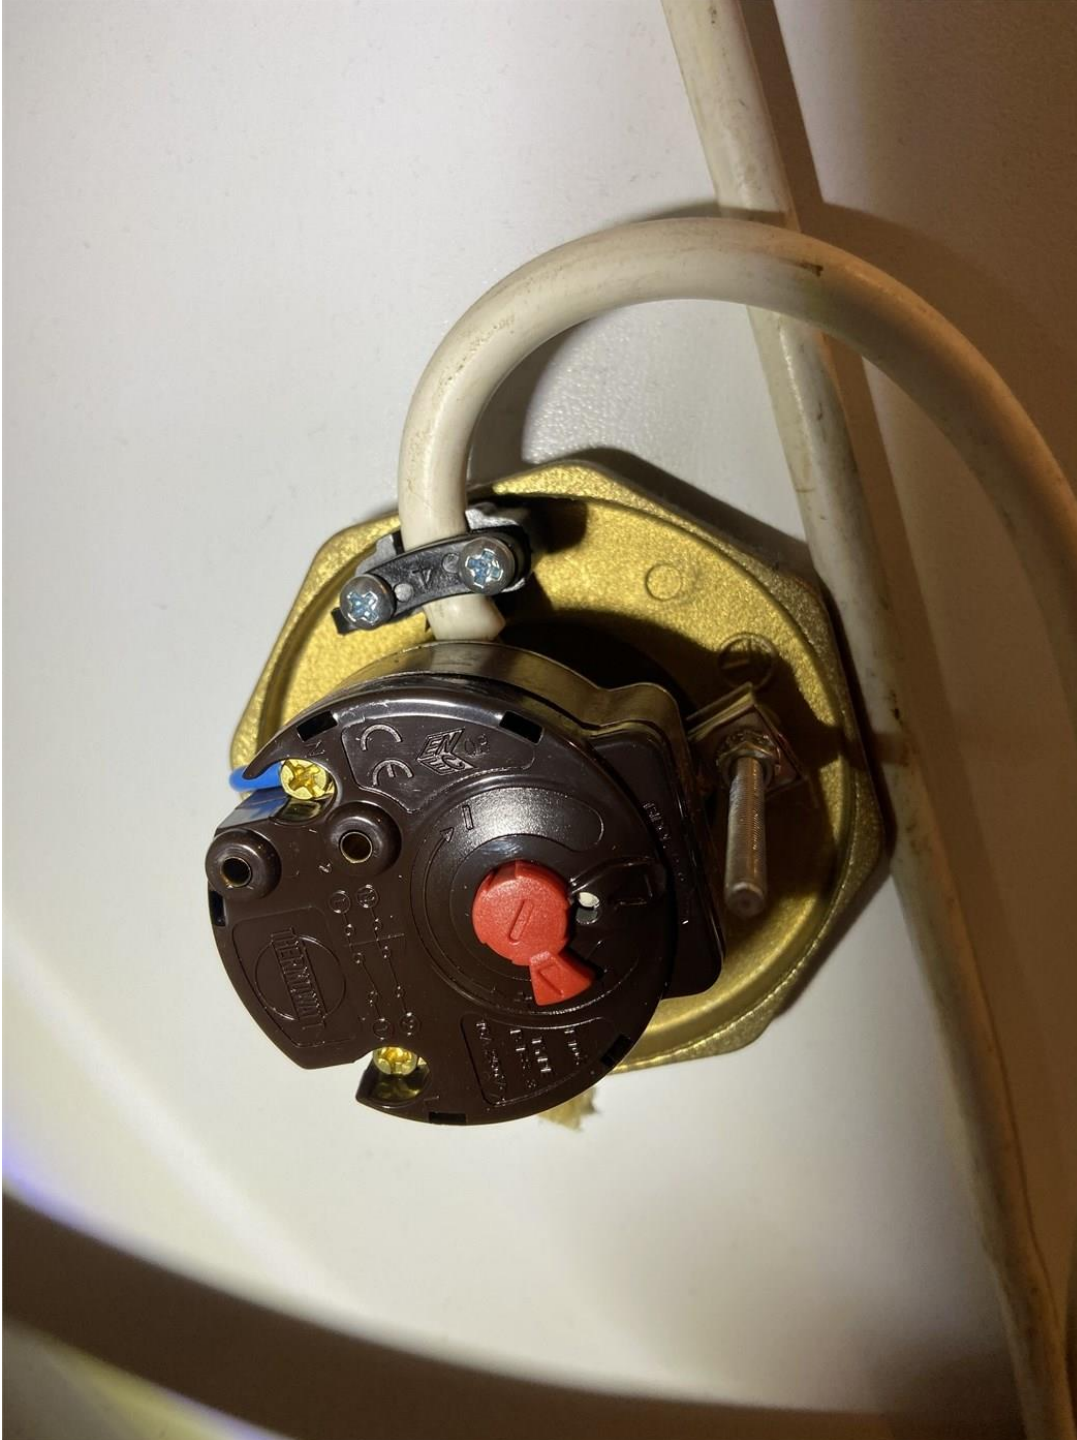
### Photo of hot water storage

Is a hot water cylinder present? Yes  
 Is the cylinder insulated? Yes  
 Is a cylinder thermostat present? Yes  
 Is the temperature on the cylinder thermostat set to 60°C or above? Yes  
 Is the temperature of the flow pipe 60°C or above? Yes  
 Is the temperature of the return pipe 50°C or above?(recirculating systems only) N/A  
 Does the overflow from the calorifier go to a tundish or drain? Yes  
 Does the storage vessel comply with relevant HSE guidance? Yes

**Risk level 1 - Minor**

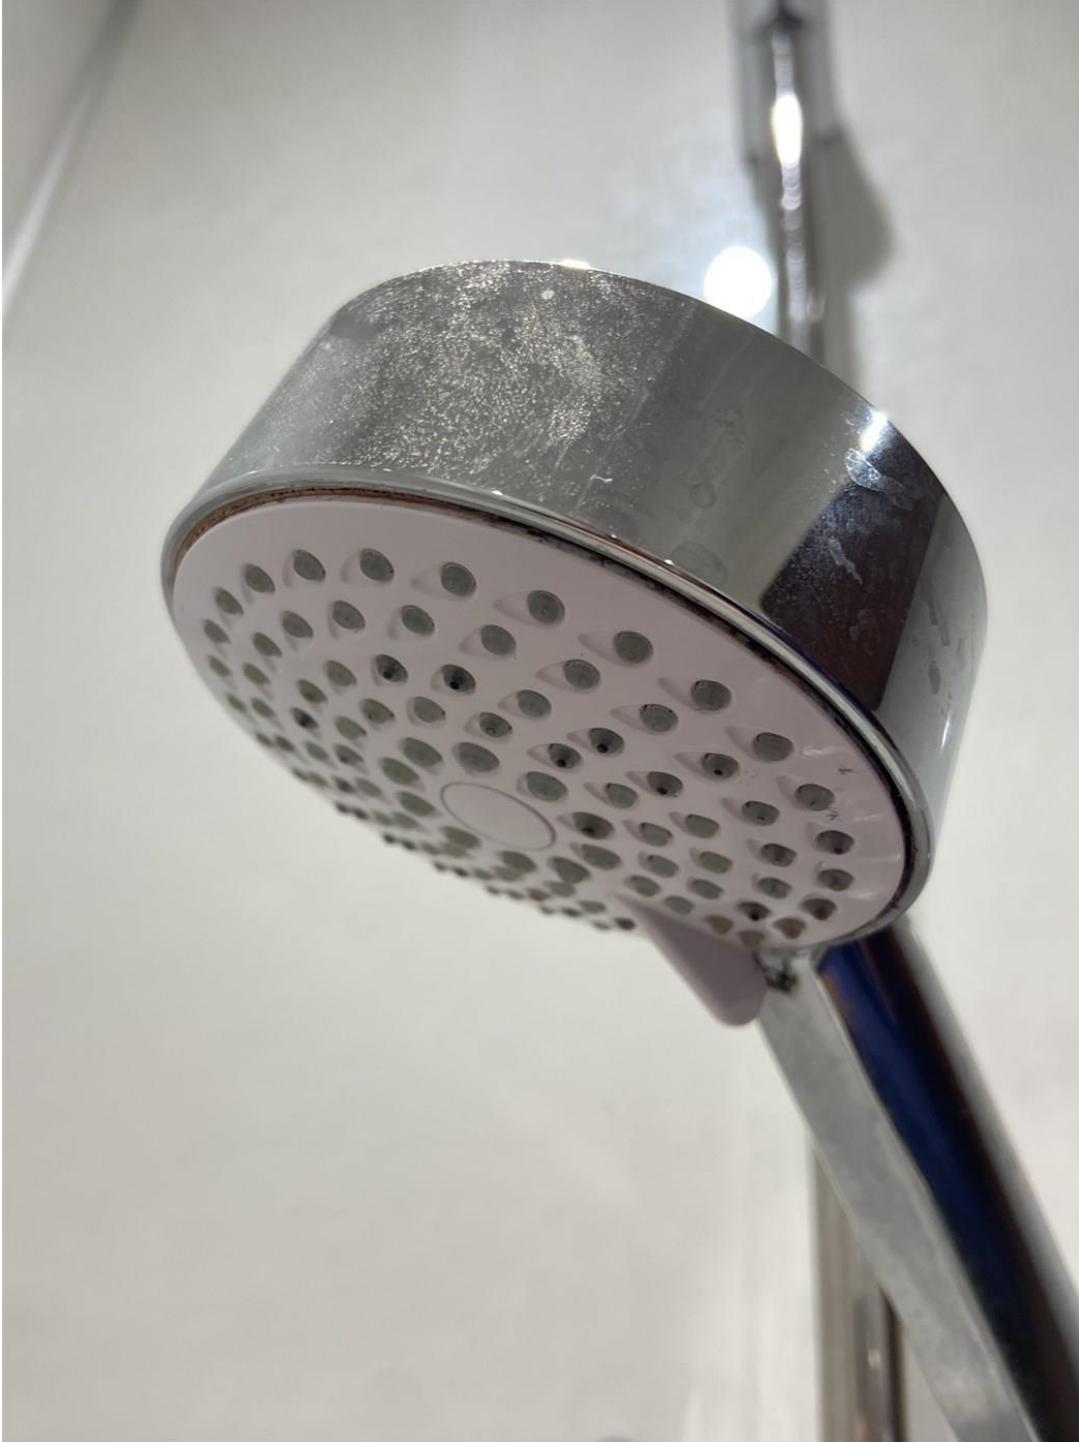
### Photo of Shower heads, taps and other spray outlets

**Are there any showers present?** Yes  
**Are there any spray taps present?** No  
**Is there a hose pipe present?** No

**Risk level 1 - Minor**

Shower head recommended to be cleaned on a 3 monthly basis.

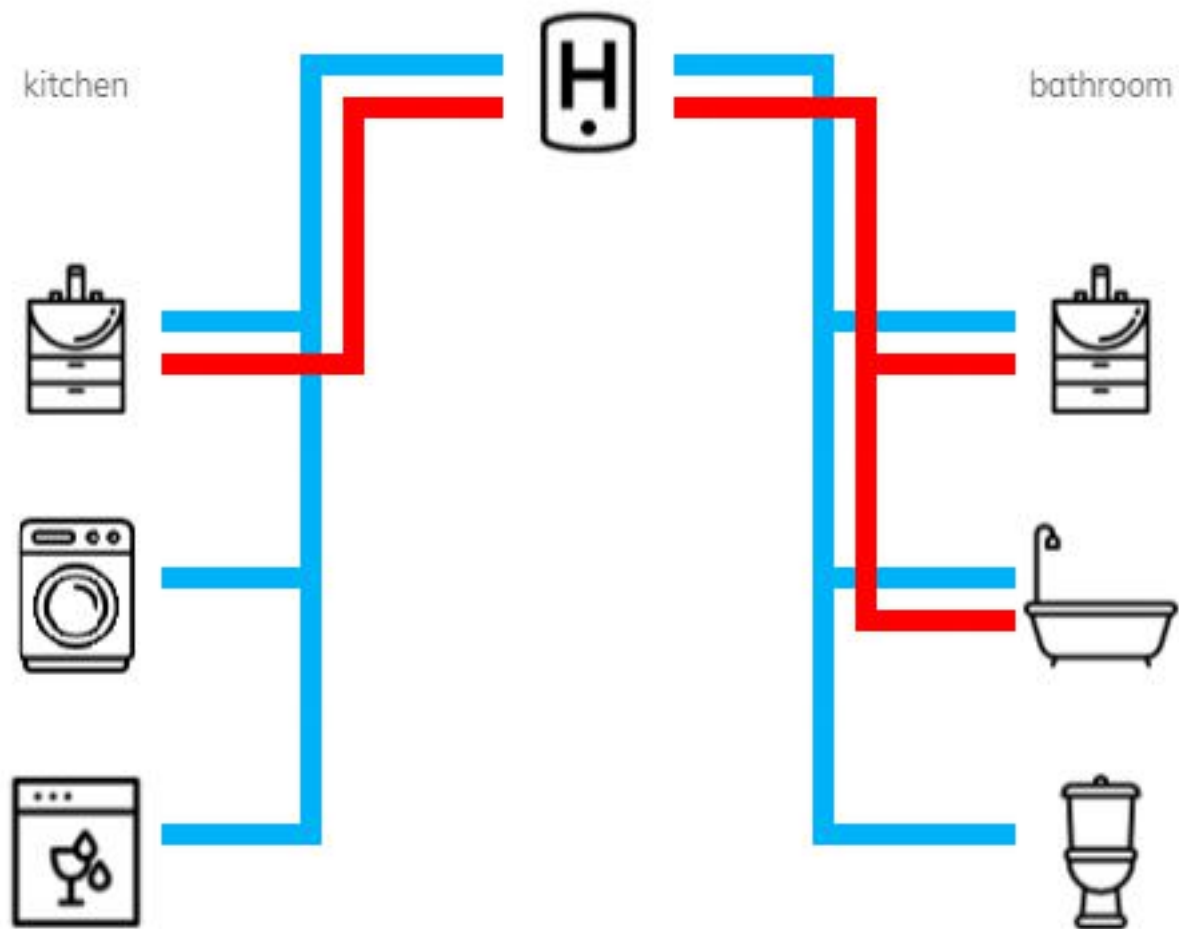
## Schematic Drawing of Water System

Electric therma cylinder providing hot water to kitchen and bathroom.
