Legionella Risk Assessment

5
Heather Avenue
Bearsden, Glasgow
G61 3AN

Reference: 000330

Assessment date: 04/02/2022

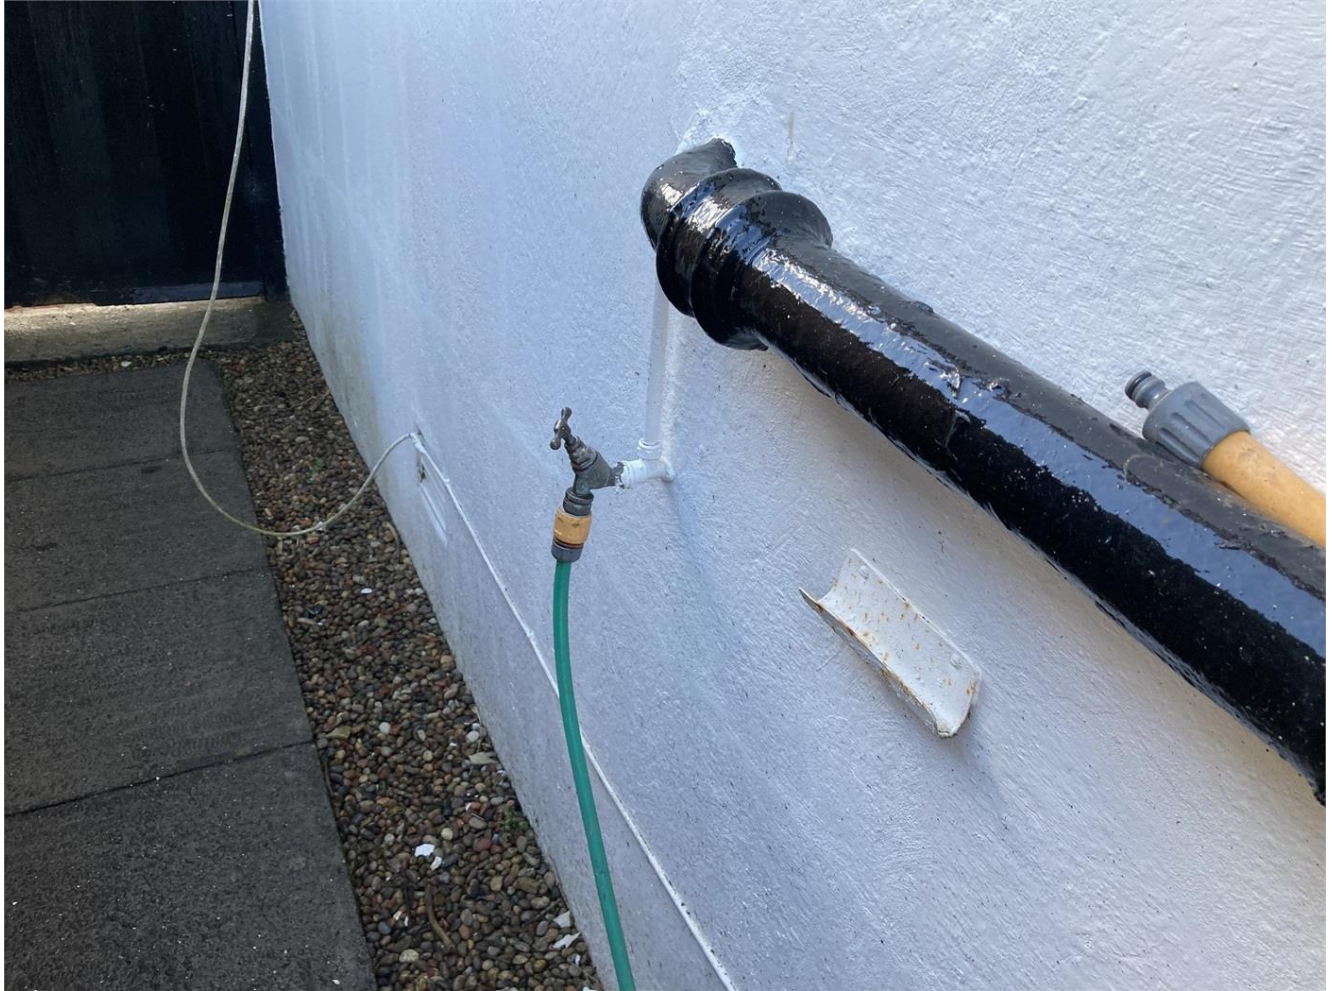
Photo of little used/unused outlets

External tap with hose attachment.

Risk level 2 - Low

All outlets should be flushed through weekly by running the outlet for at least two minutes.

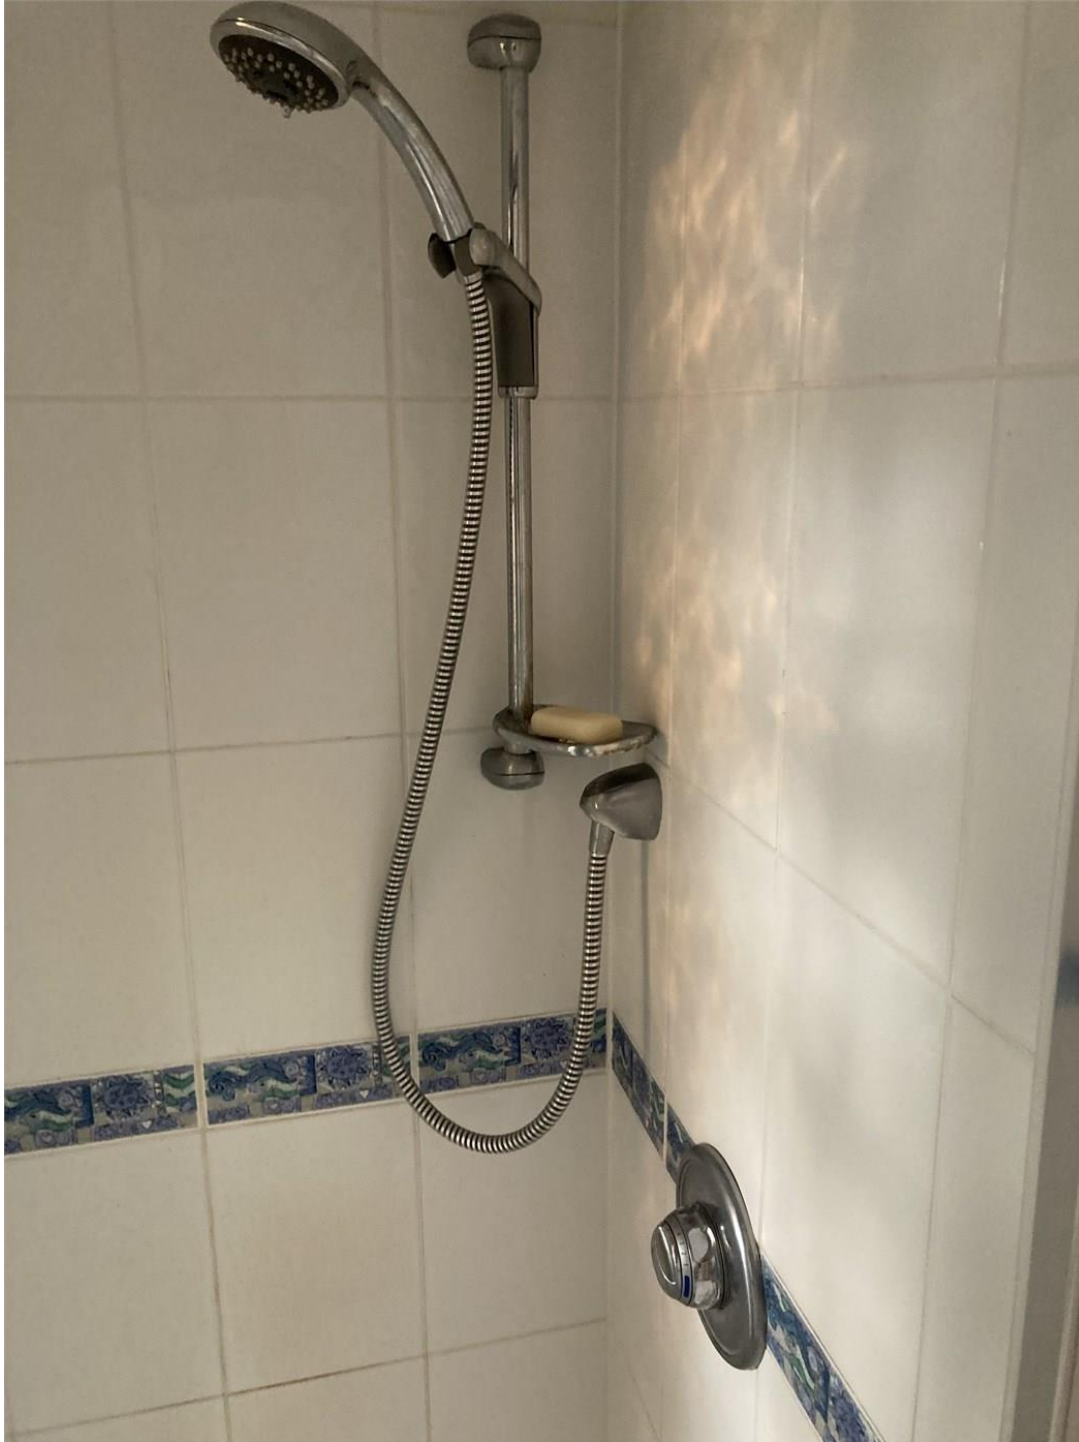
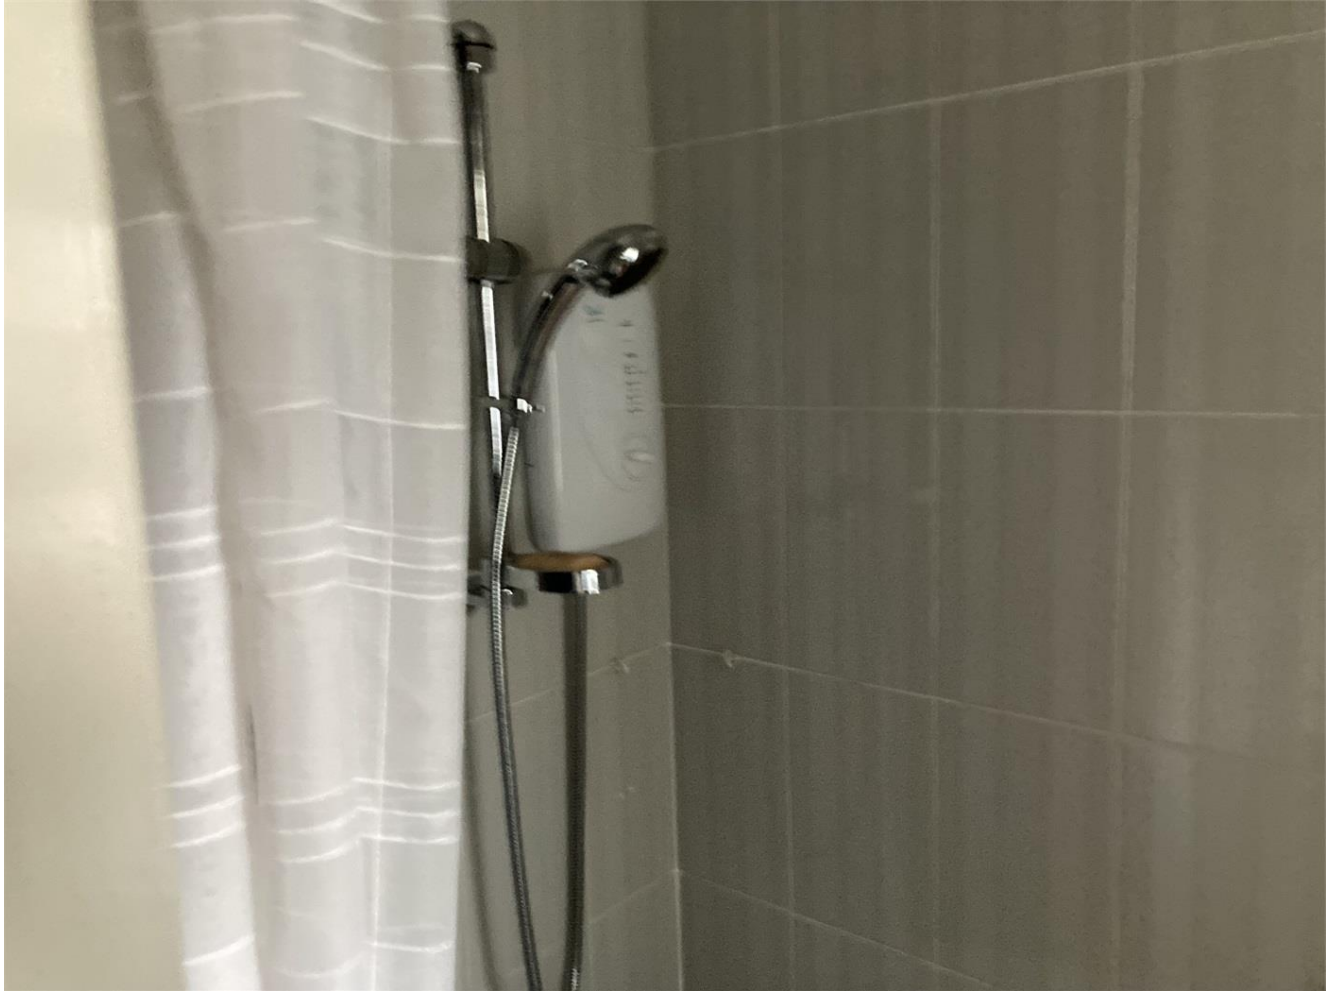
Photo of Shower heads, taps and other spray outlets

Are there any showers present? Yes
 Are there any spray taps present? No
 Is there a hose pipe present? No

Risk level 1 - Minor

Any showers/spray/taps/hose pipes should be flushed through weekly. Shower heads and other outlets should be de-scaled at least every 3-6 months. Consideration should be given to replacing spray taps with normal taps.
